**SLOPE STABILITY STUDIES OF SOME WEAK ZONES
BETWEEN HOSPITAL COLONY AND JOTSOMA
BYPASS, KOHIMA, NAGALAND**

THESIS
SUBMITTED TO
NAGALAND UNIVERSITY

IN PARTIAL FULFILMENT OF THE REQUIREMENT FOR THE
DEGREE OF DOCTOR OF PHILOSOPHY IN GEOLOGY

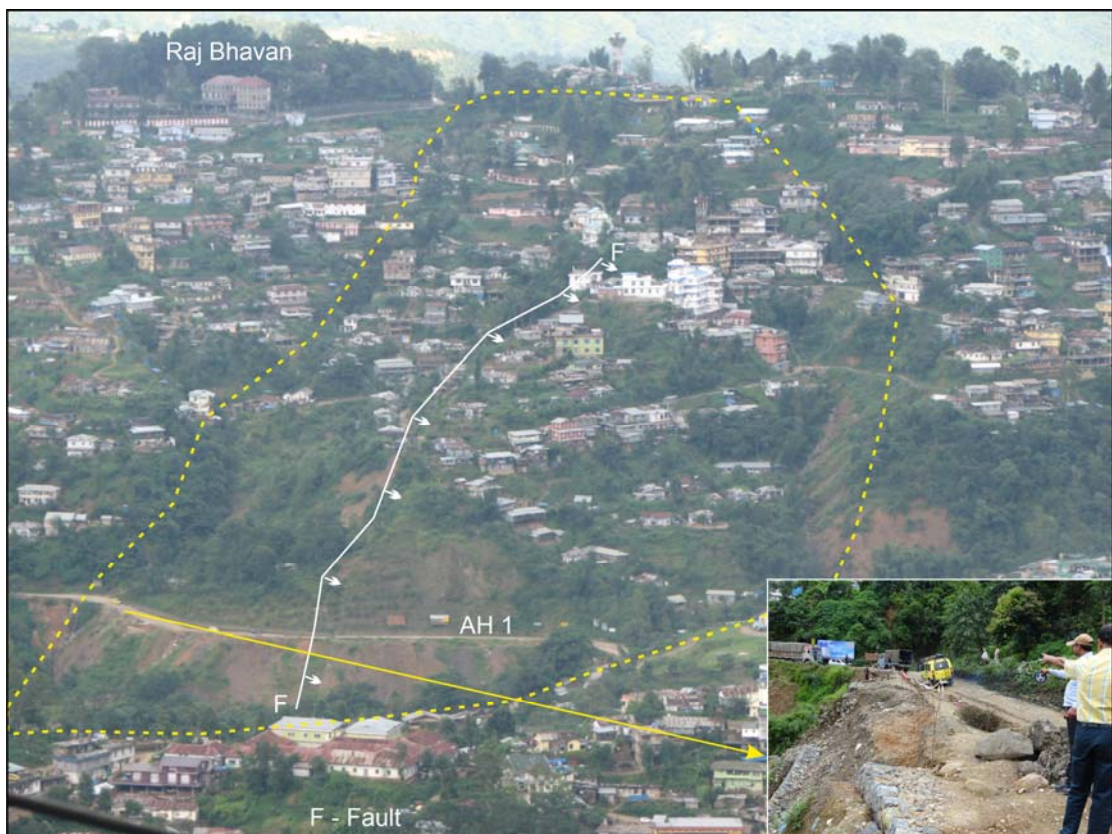
Fig. 4.1.2: Study area (yellow dotted line); arrow points to fault trace (Inset: Damaged highway)

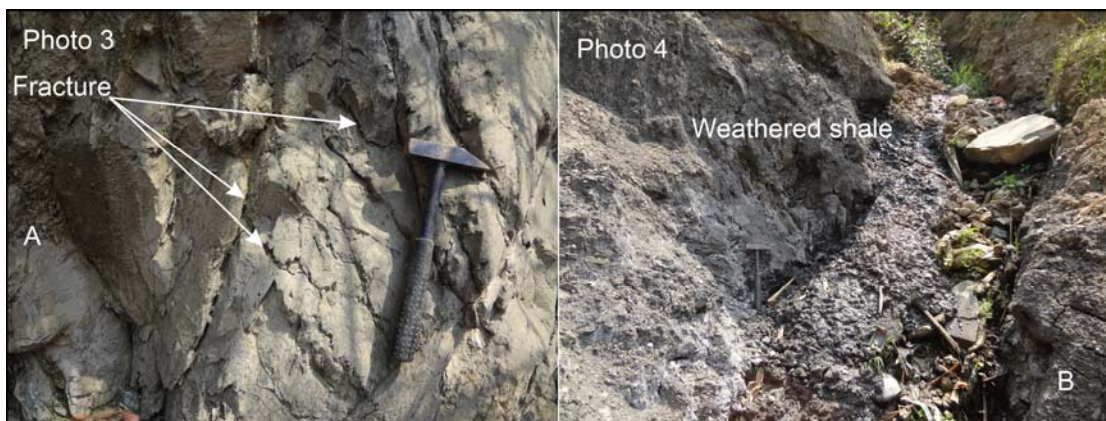
A fault trending NW-SE is observed at the northeastern edge of the study area (Fig. 4.1.8), that is parallel to the regional compression direction. This fault may be responsible for the shearing and fracturing of the bedrock (Fig. 4.1.11A) as well as controlling the stream channel flowing in the northwest. Elevated groundwater conditions have also led to intense weathering of the shale (Fig. 4.1.11B). The portion of the highway along this fault is prone to continuous damage (Fig. 4.1.2, inset). Another parallel lineament is noted ~50 m southwest of NW-SE trending fault (Figs. 4.1.2, 4.1.8). The disposition of the rocks indicates normal faulting (Fig. 4.1.12). The third lineament is observed near-vertical beds (Fig. 4.1.13A) along the southern boundary of the study area and trends E-W (Fig. 4.1.8). Slickenside preserved in the bedrock nearby (Fig. 4.1.13B) point to faulting of the rocks.

Fig. 4.1.11: A - Sheared rocks; B - Weathered shale with sulphur leaching (bleached)

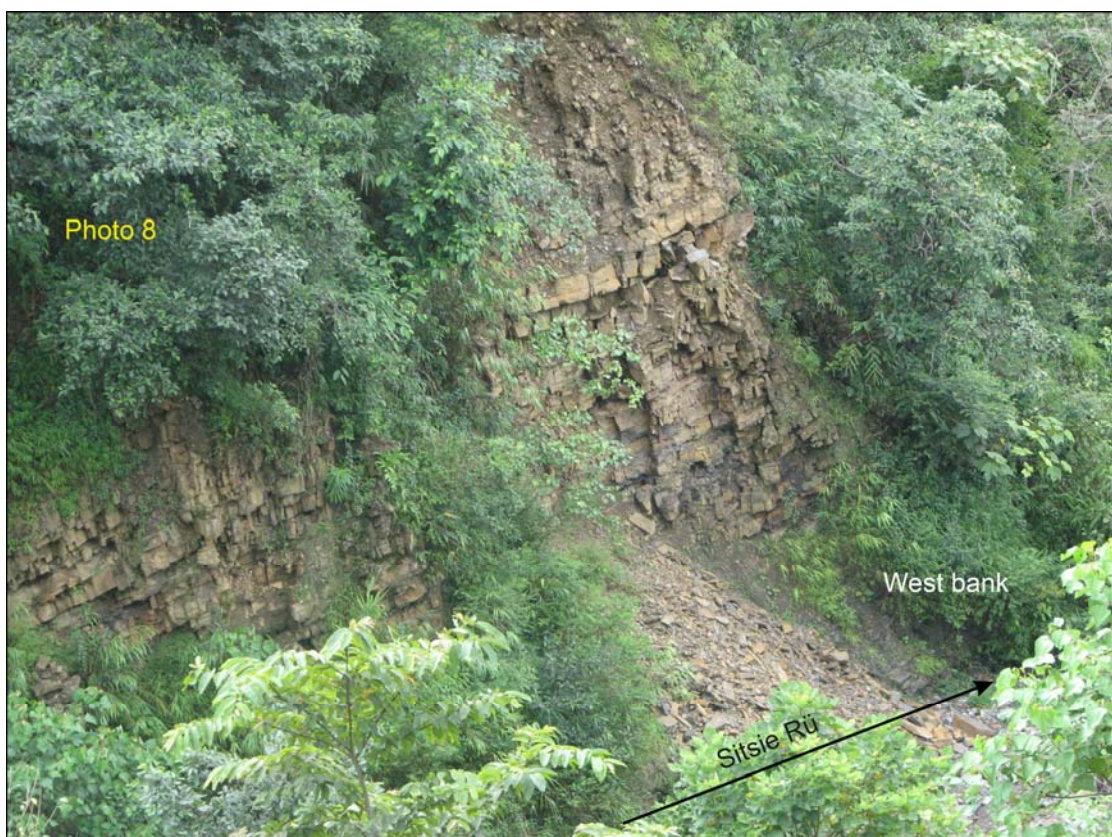
Fig. 4.1.14: Fractured and shattered rocks on the western bank of the Sitsie Rü

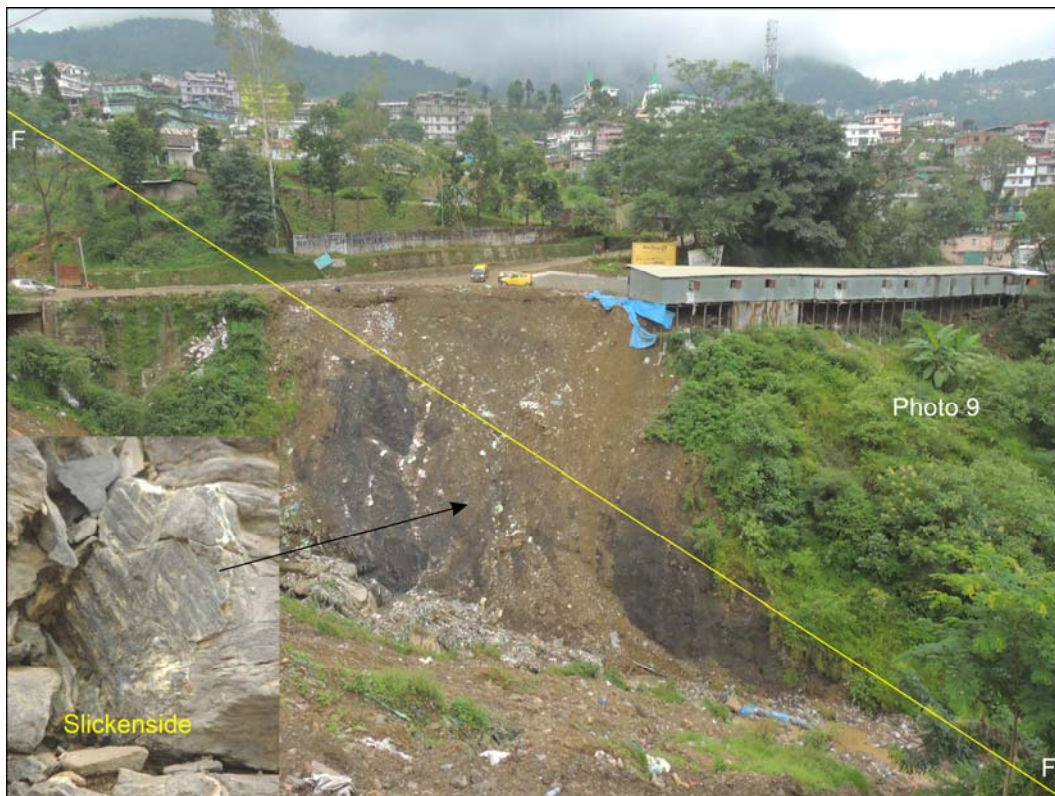
Fig. 4.1.15: Field photograph showing condition of slope due to strike-slip fault
(Inset: Slickenside on western bank of river)

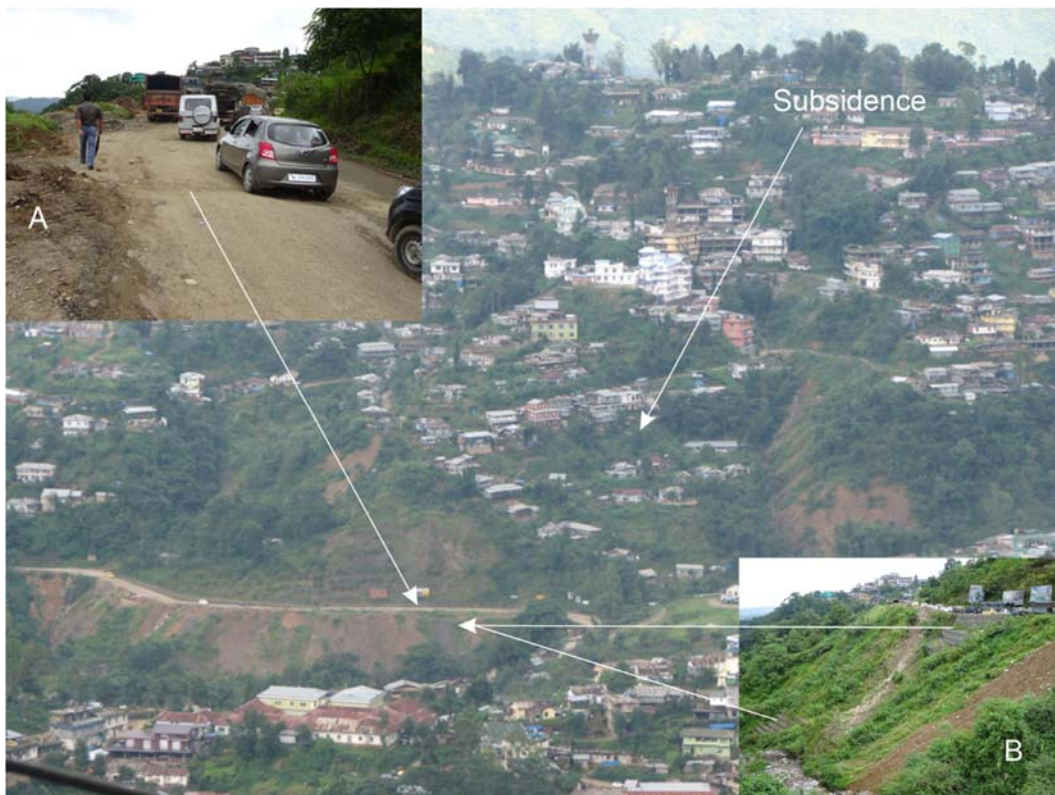
Fig. 4.1.16: Field photograph showing subsidence on the eastern bank of the stream
(Inset: A - Subsidence of highway; B - Retaining walls for road support)

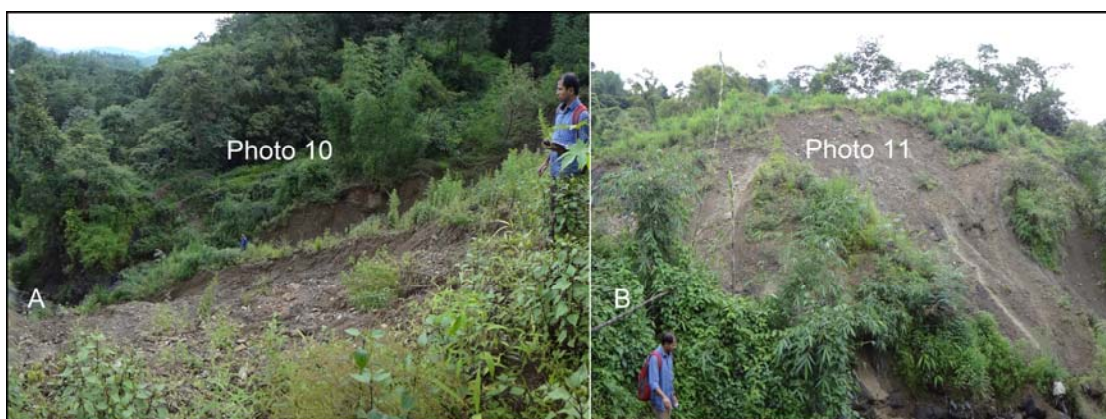
Fig. 4.1.17: A - Loose debris constituting slope material; B - Debris flows on unstable slope

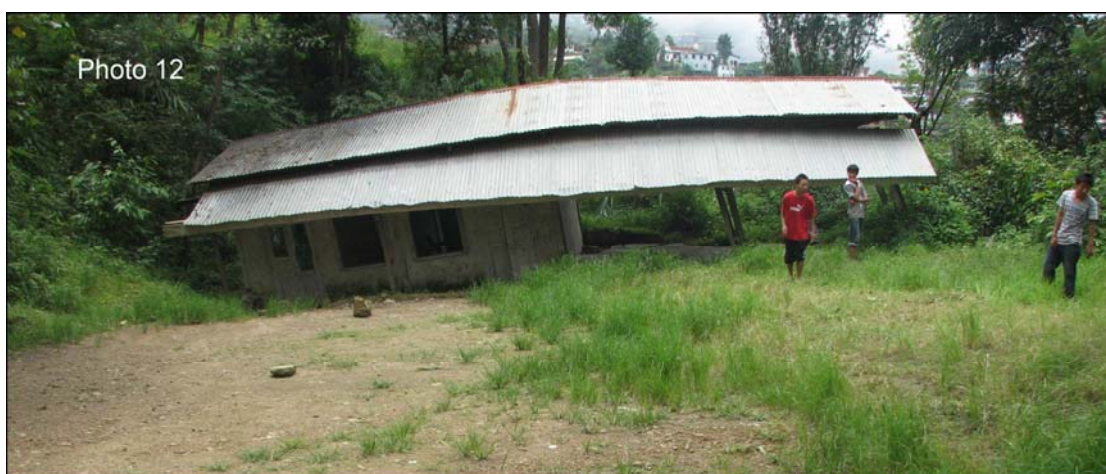
Fig. 4.1.18: House damaged due to differential settlement (Slip zone 1)

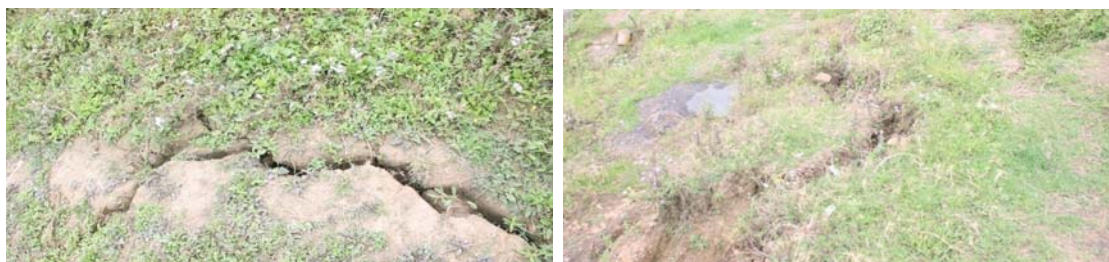
Fig. 4.1.21: Tension fractures in the lower elevations of the study area

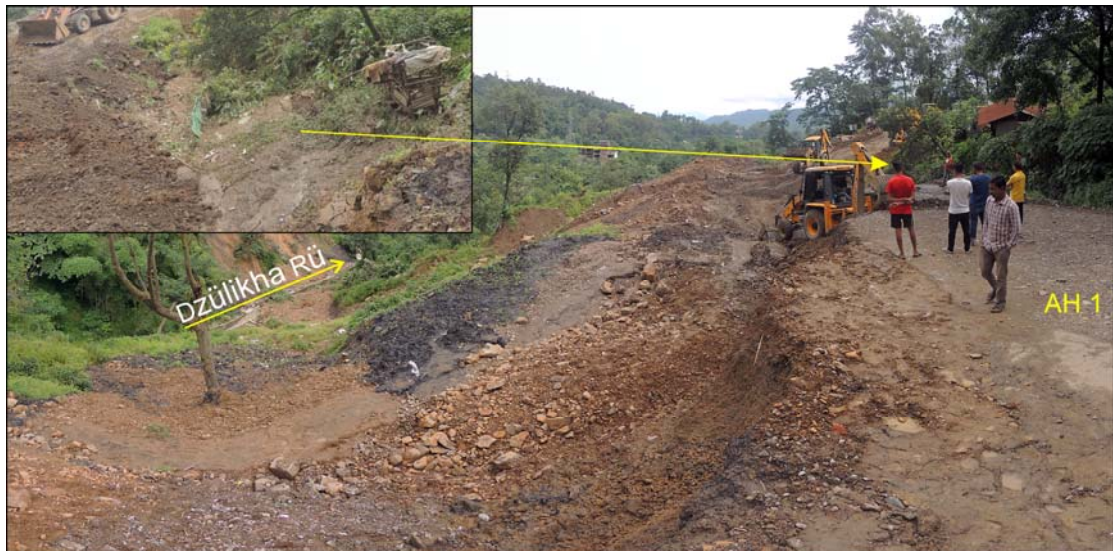
The study area continuous to see subsidence and minor creep in several areas notably below PHED store, in and around the Merhülietsa Ao Baptist church, and specially where the shear fractures cut across the highway (Aier, et al., 2012).

Fig. 4.2.2: Affected area along AH 1; (Inset - Water logged area)

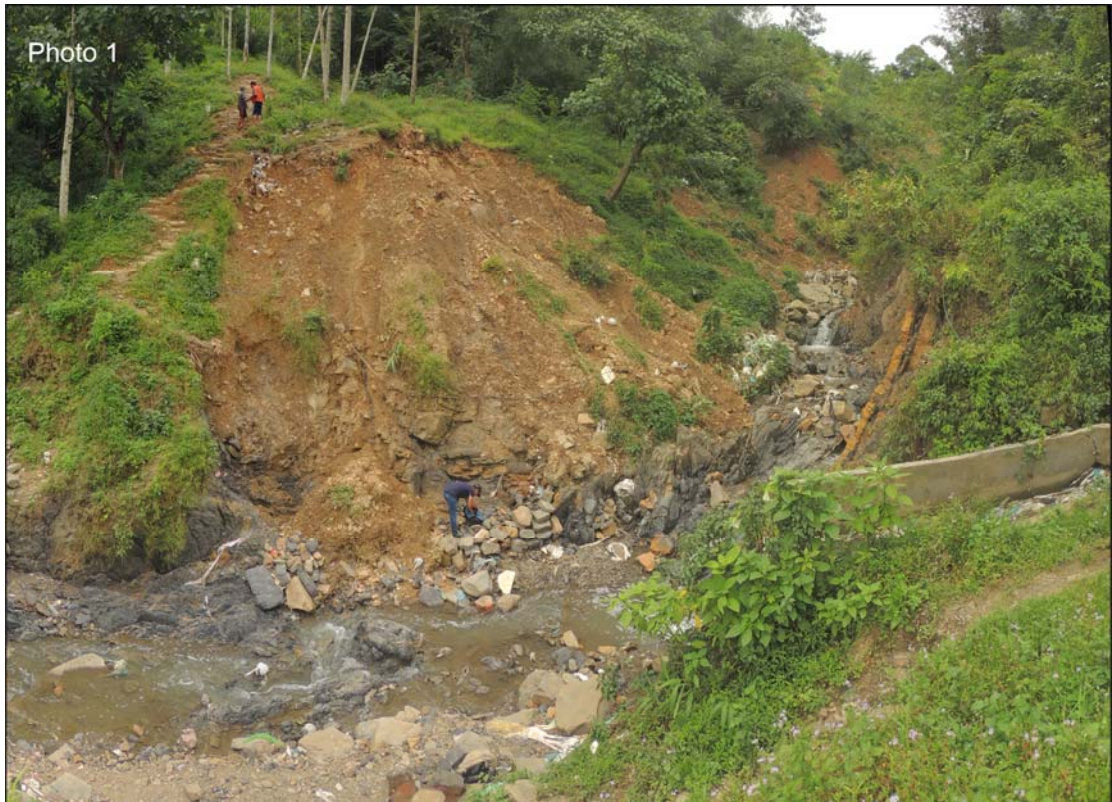
Fig. 4.2.9: Toe erosion along Dzulikha Rü

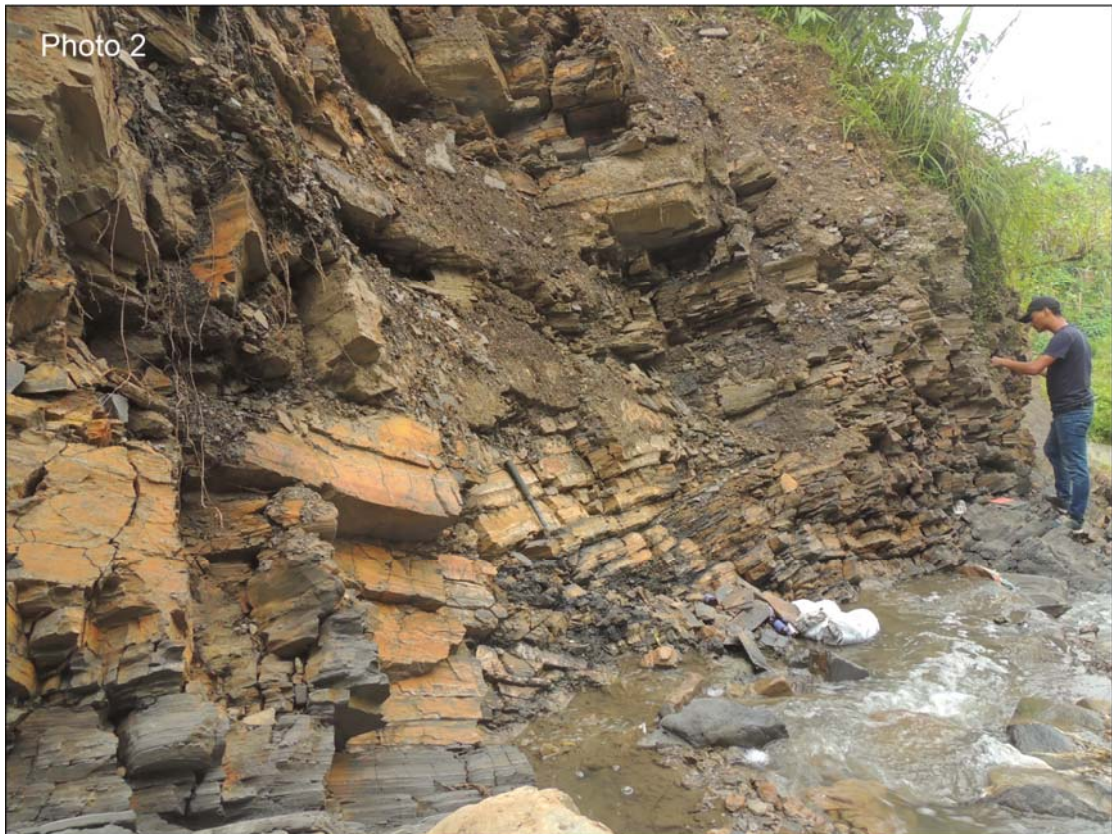
Fig. 4.2.10: Jointed and fractured rocks on the western bank of Dzulikha Rü

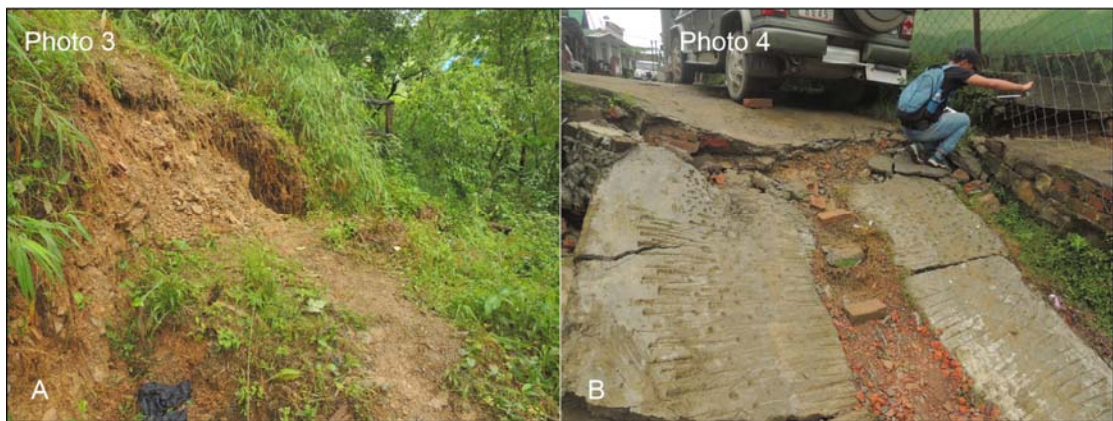
Fig. 4.2.11: A - Tension crack developed on the slope; B - Road damaged due to subsidence

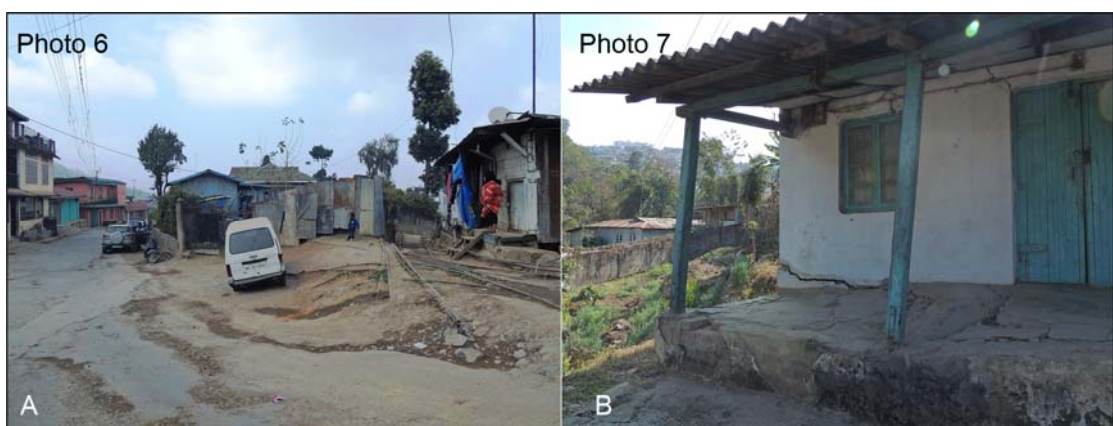
Fig. 4.2.13: A - Subsidence along the road section; B - Damaged house

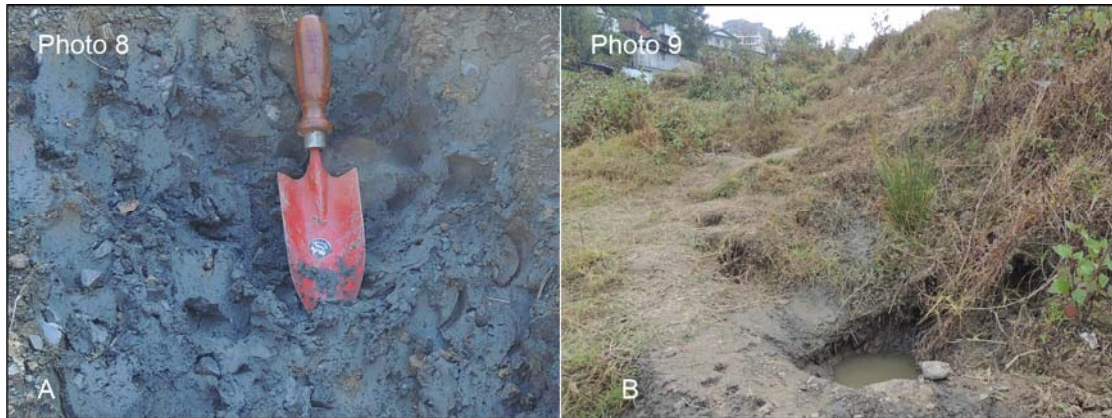
Fig. 4.2.14: A - Slope material constituting clay deposits; B - Water seepages observed during dry season

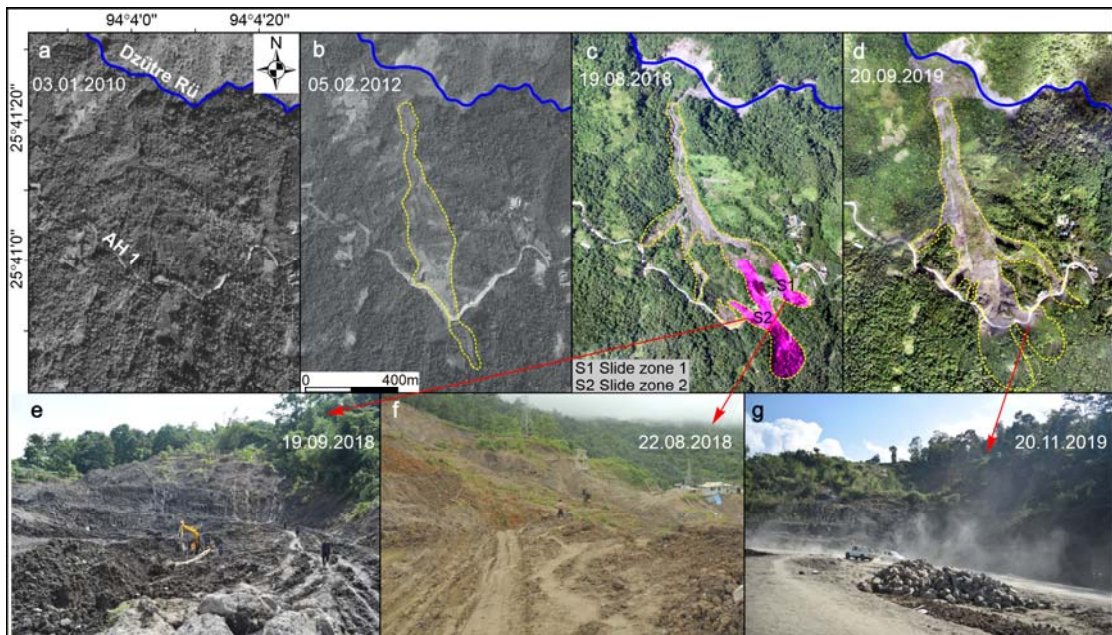
Fig. 4.3.2: **a** Google Earth (GE) image of 2010 before landslide; **b** GE image of 2011 landslide (yellow broken line - boundary of affected area); **c** Unmanned aerial vehicle (UAV) image showing landslides of 2018; **d** UAV image showing landslide of 2019; **e, f** Photos of damaged portions of highway at locations S1 & S2 due to landslides in 2018; **g** Photo of repaired highway after 2019 landslide event

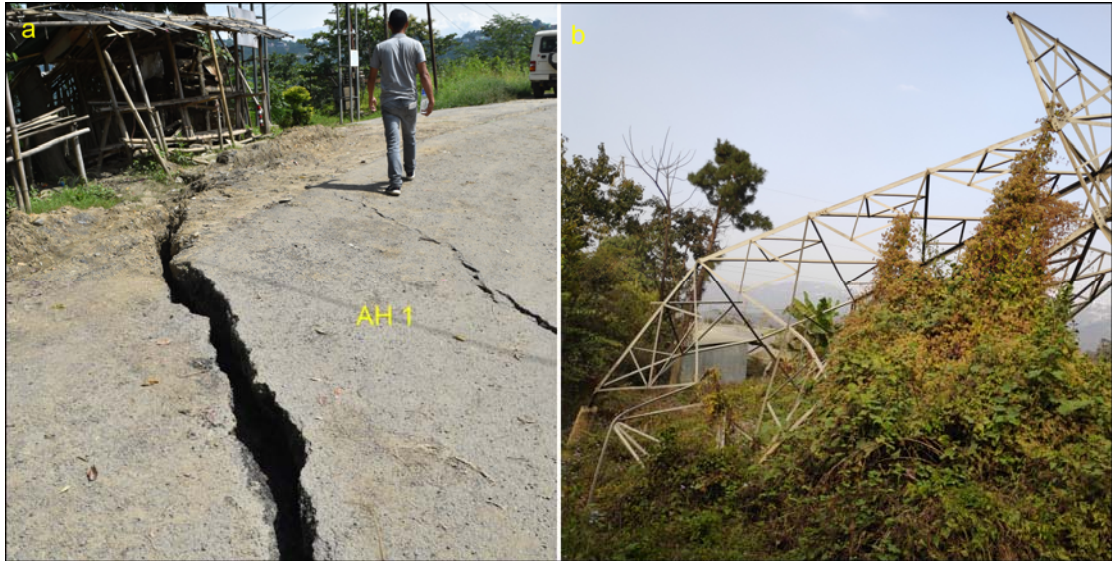
Fig. 4.3.3: Effects of the landslides - **a** Large fissure on the highway at the eastern edge of the slide zone; **b** Collapsed pylon (major support for power cables to Kohima)

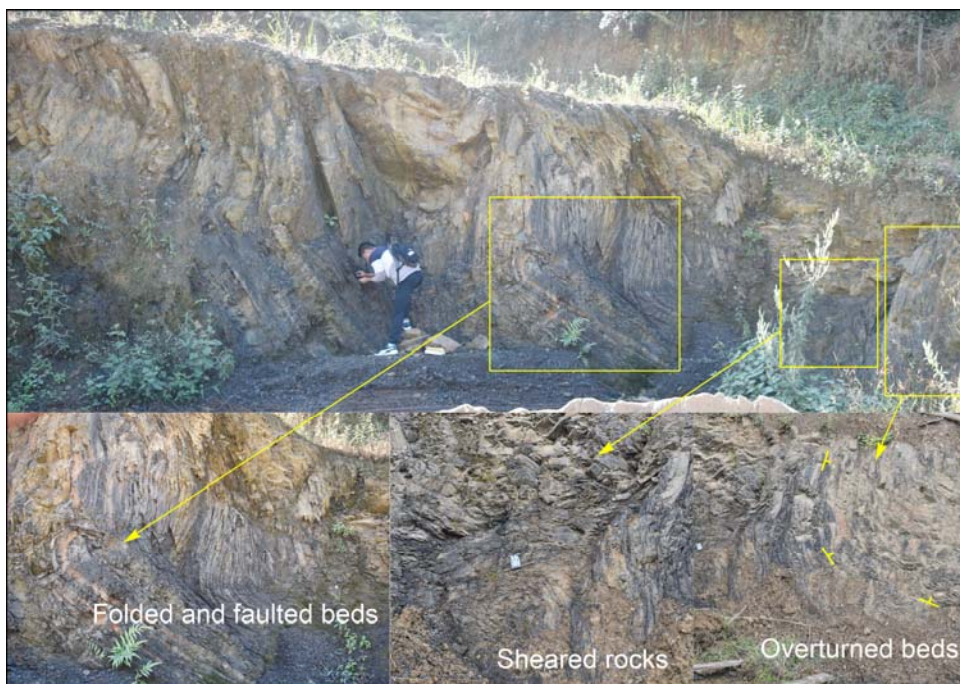
Fig. 4.3.11: Outcrop of intensely folded and sheared rocks (See fig. 4.3.9)

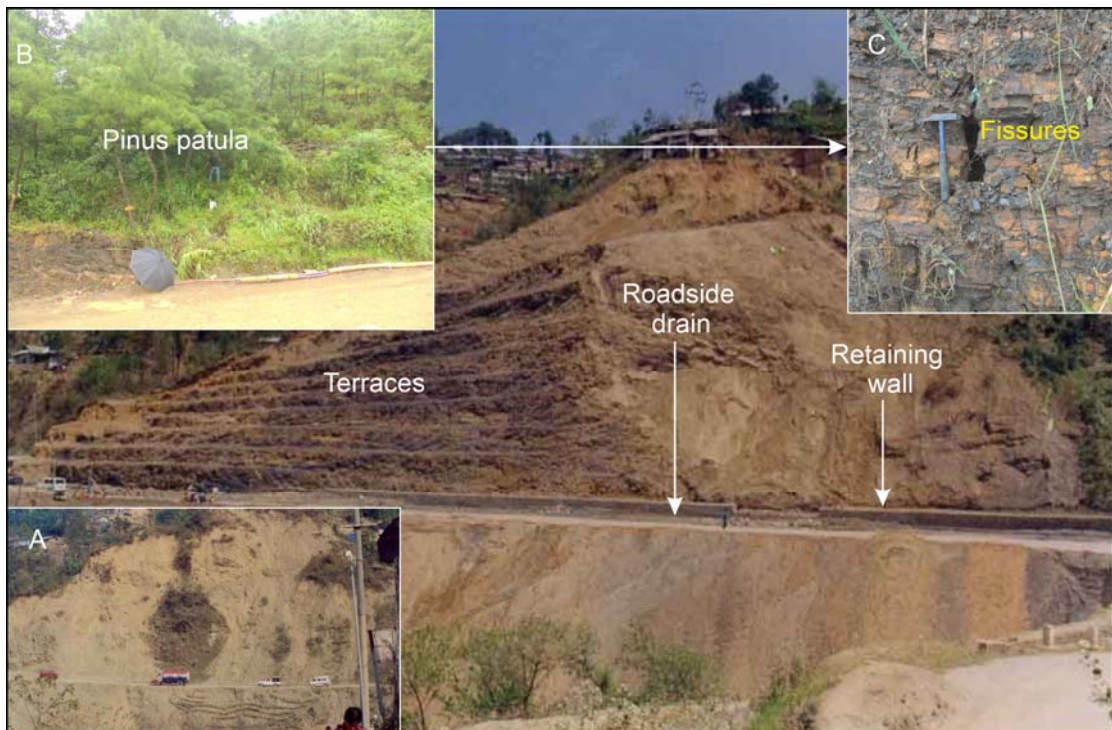
Fig. 5.1.1: Previous mitigation measures in the weak zone (Inset: A - Landslide during 2005; B - Needle pine plantation; C - Open fissures)

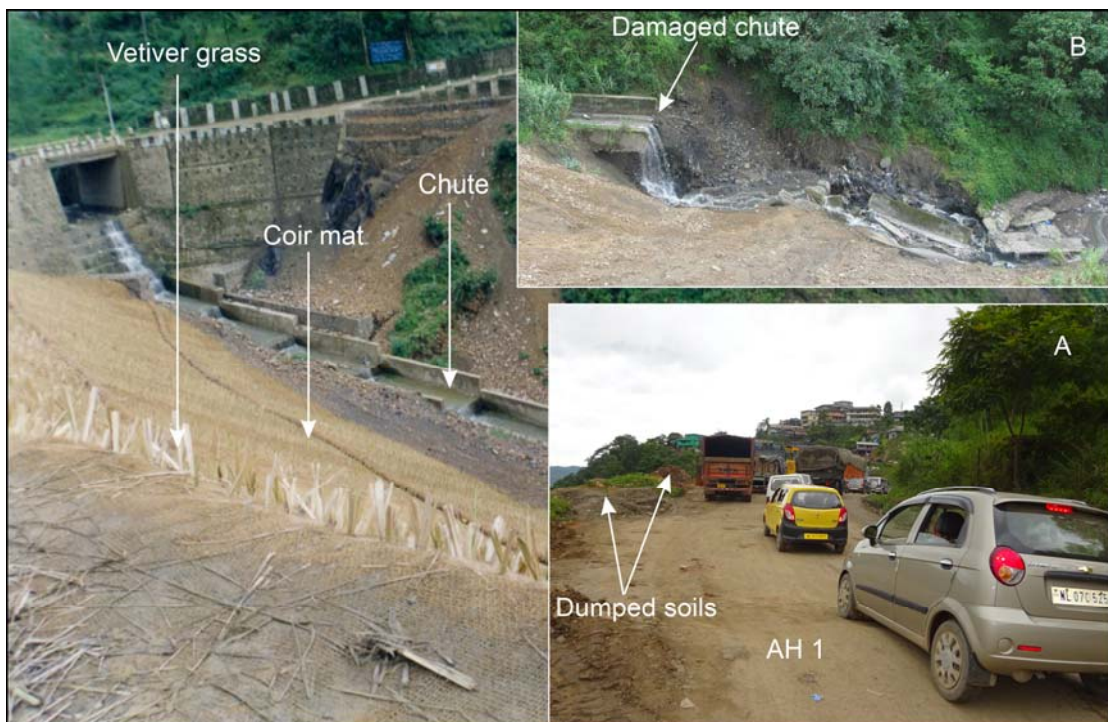
Fig. 5.1.2: Mitigation measures taken up during 2005-06 (Inset: A - Soils dumped along the highway; B - Chute damaged)
