**GEOLOGICAL AND GEOTECHNICAL STUDIES OF
SOME LANDSLIDES IN AND AROUND KOHIMA
TOWN, NAGALAND**

Submitted in partial fulfillment of the requirement of the
Degree of Doctor of Philosophy in Geology
of Nagaland University
2024

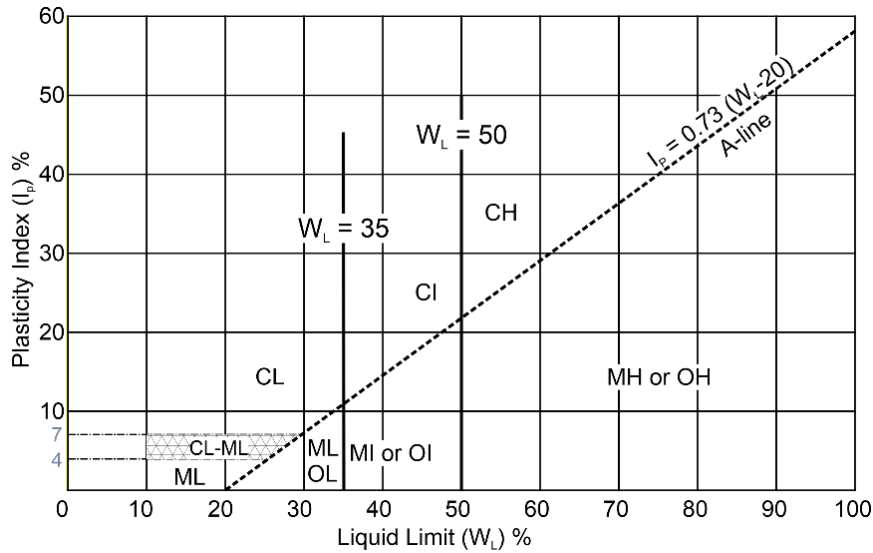
Fig. 3.1: Plasticity chart according to BIS, 1970

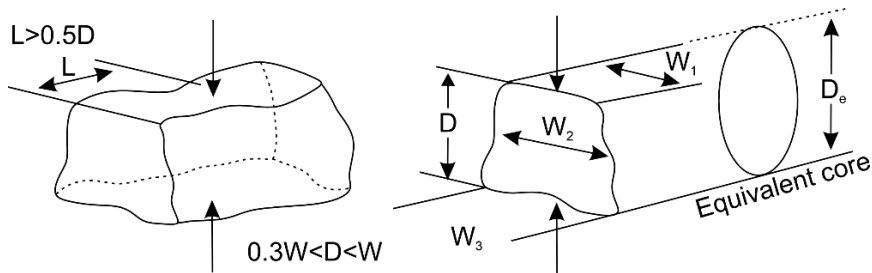
Fig. 3.2: Requirement of specimen shape for irregular lump test

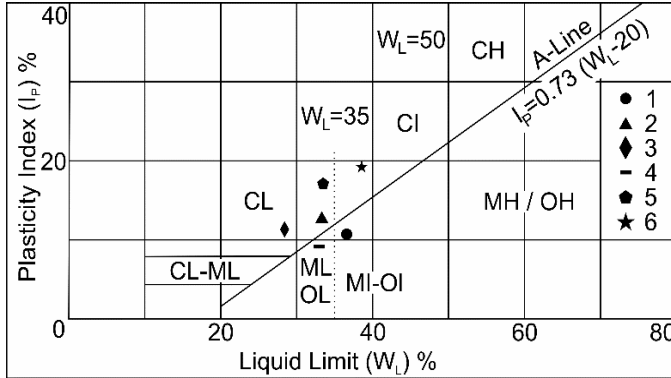
The consistency of fine-grained soil is heavily influenced by its moisture content. During heavy rain, slope material become saturated, and the water content may surpass the liquid limit of the soil. The soil then behaves like a fluid, ultimately failing. The average liquid limit ranges from 28.39 to 38.59, and the plasticity index from 9.08 to 19.25 (Table 4.1.1). Snethen et al. (1977) attribute these findings to low degree of expansion. The average shrinkage limit of these samples is 29.25. According to Holtz and Gibbs (1956), such values suggest a relatively low rate of expansion. The average plasticity index of the six soil samples tested is 13.38. The plasticity chart (Fig. 4.1.2) for samples of inorganic silts and clays (BIS, 1970) shows low to moderate plasticity.

Fig. 4.1.2 Plasticity chart of the soil samples (M - Inorganic silt/very fine sand; C - Inorganic clay; O - Organic silt/clay; L - Low compressible and plastic silt/clay; I - Medium compressible and plastic silt/clay; H - High compressible and plastic silt/clay)

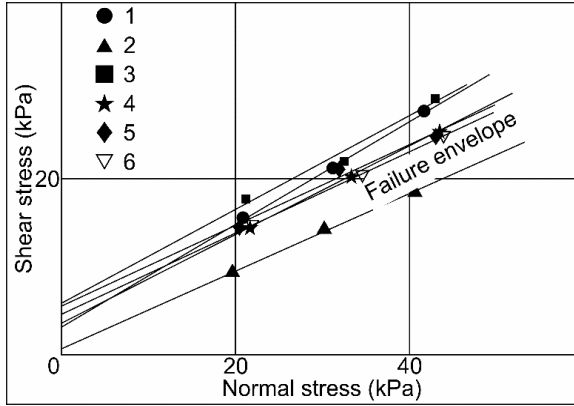
Fig. 4.1.3: Failure curves of samples

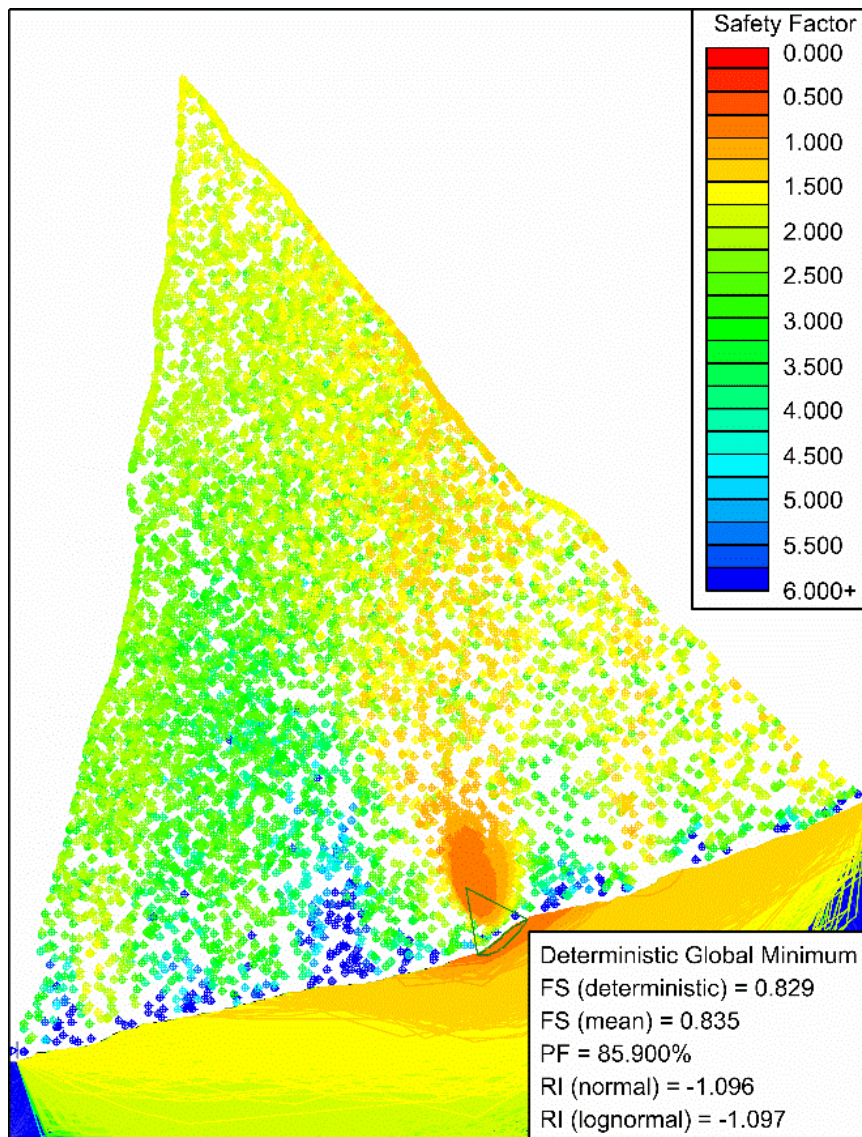
Fig. 4.1.4 Slope stability analysis with global minimum slip surface showing a safety factor of 0.829

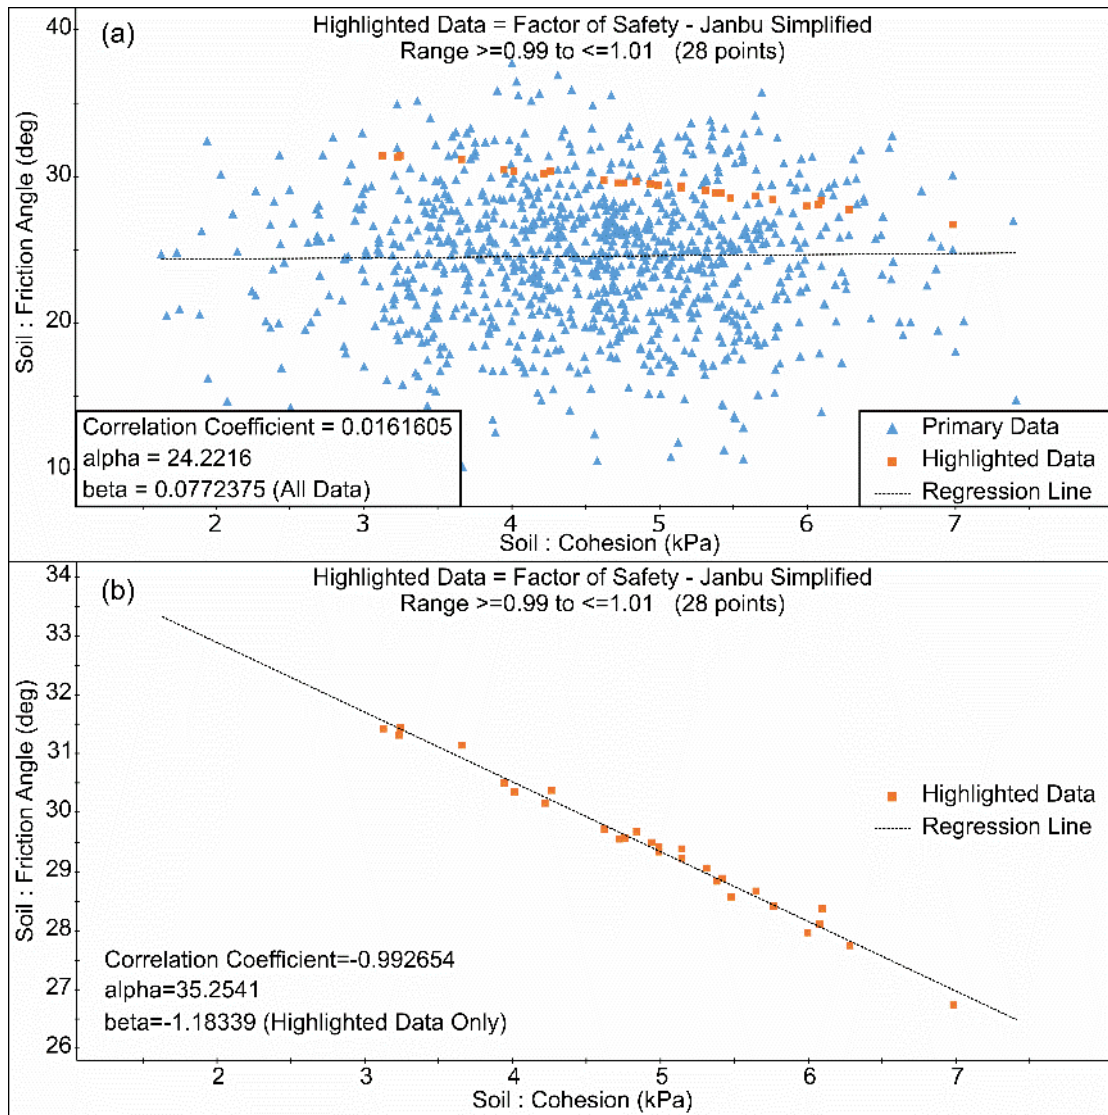
Fig. 4.1.5 (a) Scatter plots of correlation between cohesion and friction angle to the safety factor, (b) Linear best-fit-line relationship between cohesion and friction angle for a FoS=1

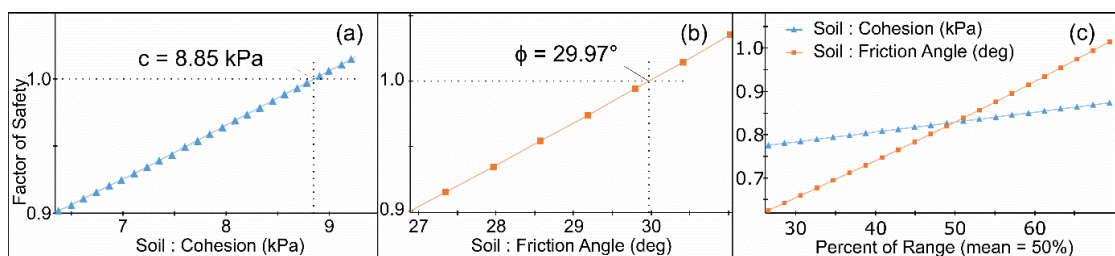
The sensitivity curves for cohesiveness (Fig. 4.1.6a) and friction angle (Fig. 4.1.6b) with respect to FoS have modest slopes, indicating that changes in soil-parameter values have a moderate impact on slope stability. According to the sensitivity curves, the cohesiveness and friction angle values are 8.85 kPa and 29.97° respectively, corresponding to steady slope conditions at a safety factor of 1. Friction angle variation has a greater impact on the safety factor since the curve (Fig. 4.1.6c) is steeper than the cohesion sensitivity curve.

Fig. 4.1.6 Sensitivity curves (a) Cohesion at the FoS equivalent to 1, (b) Friction angle at the FoS equivalent to 1, (c) Plots for soil variables, cohesion, and friction angle

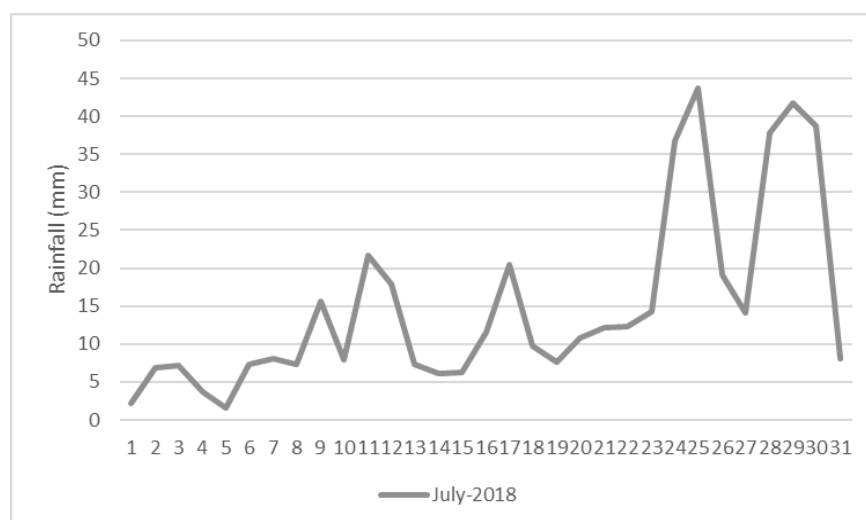
Fig. 4.1.7 Precipitation curve of Pezielietsie Colony

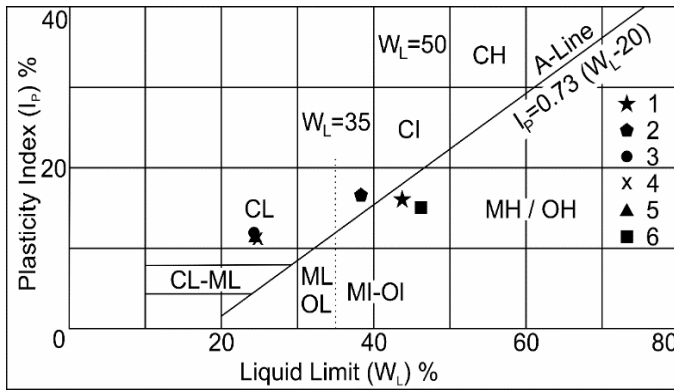
According to the plasticity chart (Fig. 4.2.2), soil samples 2, 3, 4, and 5 fall in the CL field, indicating inorganic clays with low to medium plasticity. Samples 1 and 6 are highly plastic with a silty to clayey composition.

Fig. 4.2.2: Plasticity chart of the soil samples (M - Inorganic silt/very fine sand; C - Inorganic clay; O - Organic silt/clay; L - Low compressible and plastic silt/clay; I - Medium compressible and plastic silt/clay; H - High compressible and plastic silt/clay)

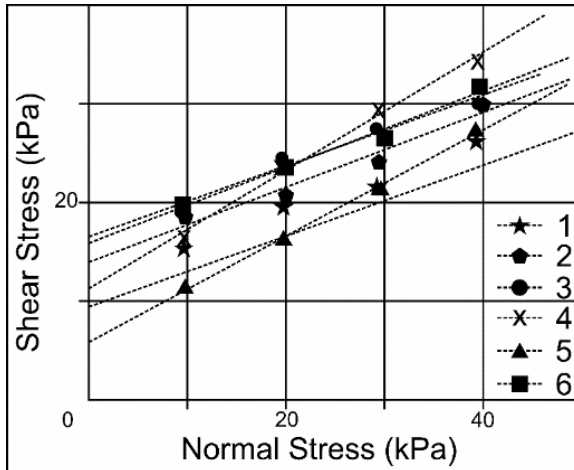
Fig. 4.2.3: Failure curves of samples

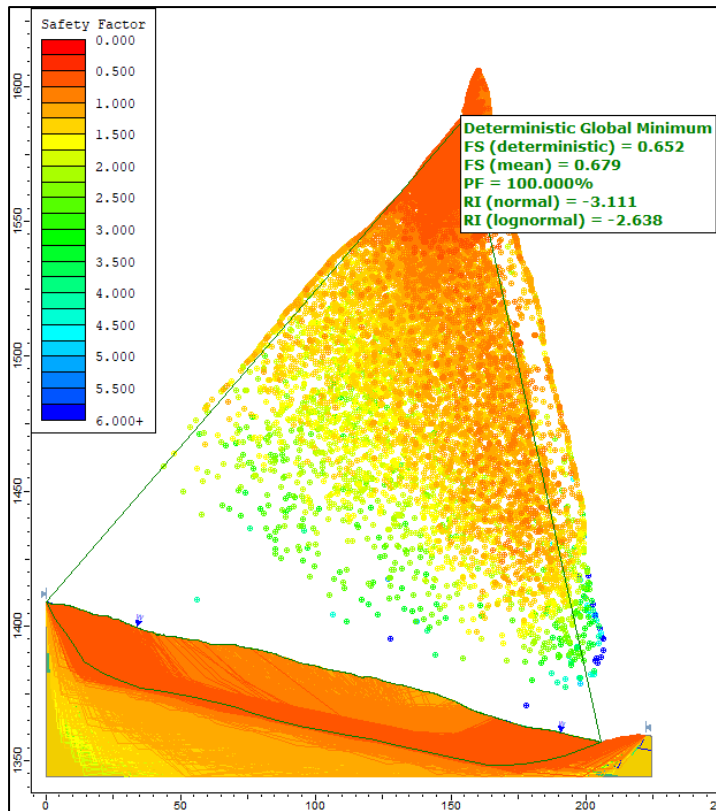
From back analysis of the slope, the probability of slope failure is estimated at 100%, whereas the FoS is 0.652 (Fig. 4.2.4). Therefore, the reliability index of the slope is -3.111, which is much below the safety limit of 3.

Fig. 4.2.4: Slope stability analysis with global minimum slip surface showing a safety factor of 0.652

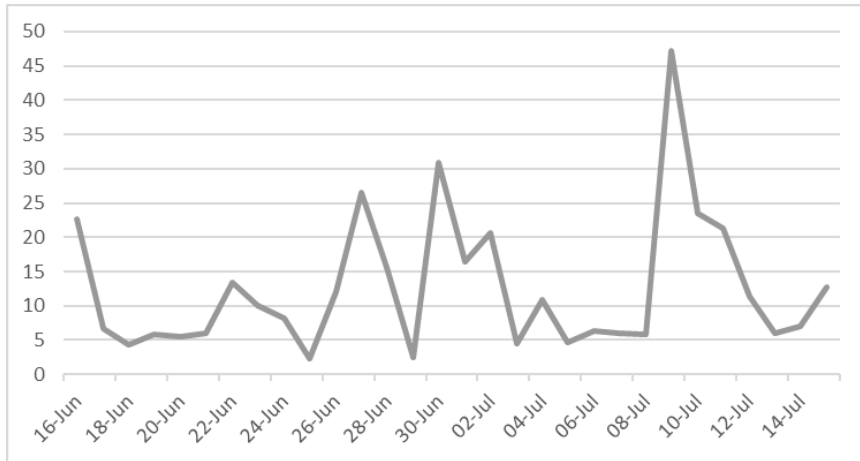
Fig. 4.2.5: Precipitation curve of Peraciezie Colony

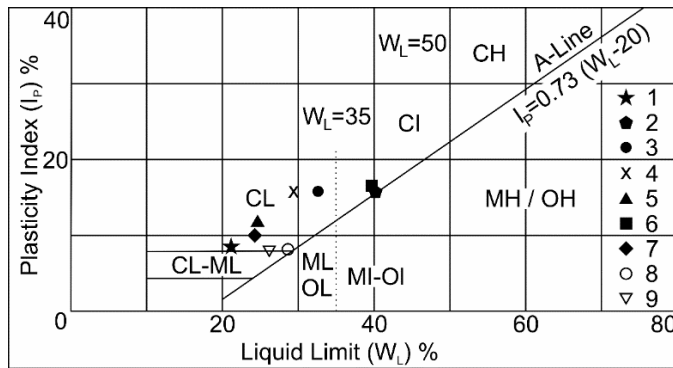
Fig. 4.3.2: Plasticity chart of the soil samples (M - Inorganic silt/very fine sand; C - Inorganic clay; O - Organic silt/clay; L - Low compressible and plastic silt/clay; I - Medium compressible and plastic silt/clay; H - High compressible and plastic silt/clay)

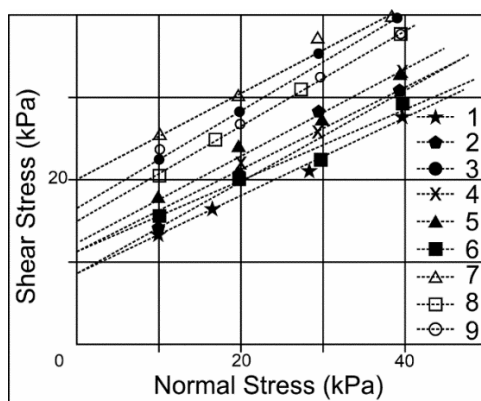
Fig. 4.3.3 Failure curves of the samples

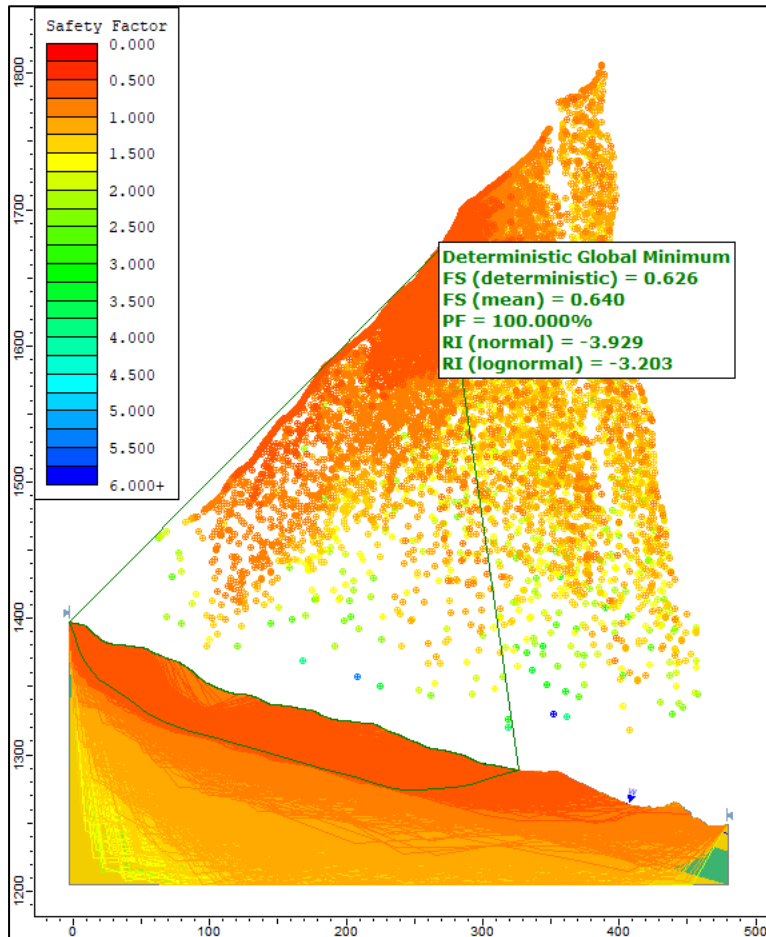
The probability analysis (Fig. 4.3.4) indicates that the deterministic safety factor is 0.626, with a failure probability of 100%. This indicates that all analysed samples had a FoS <1. In this case a RI of -3.929 was obtained, which is insufficient for slope safety.

Fig. 4.3.4: Slope stability analysis with global minimum slip surface showing a safety factor of 0.626

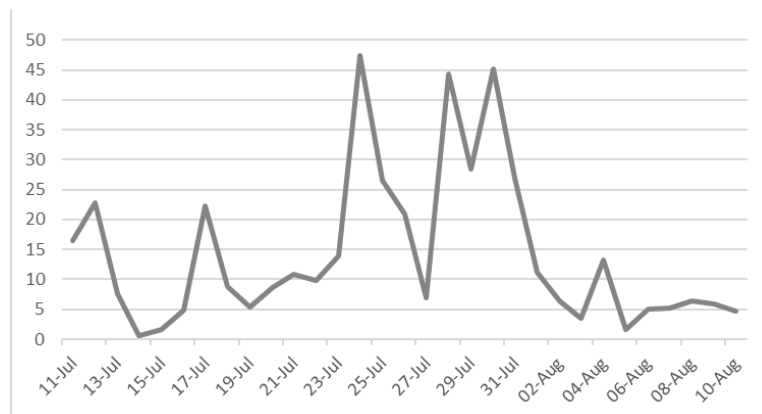
Fig. 4.3.5: Precipitation curve of the 2018 Peraciezie Colony slide

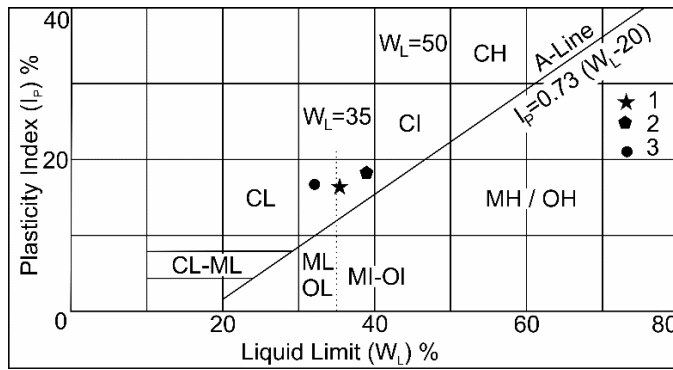
Fig. 4.4.2: Plasticity chart of the soil samples (M - Inorganic silt/very fine sand; C - Inorganic clay; O - Organic silt/clay; L - Low compressible and plastic silt/clay; I - Medium compressible and plastic silt/clay; H - High compressible and plastic silt/clay)

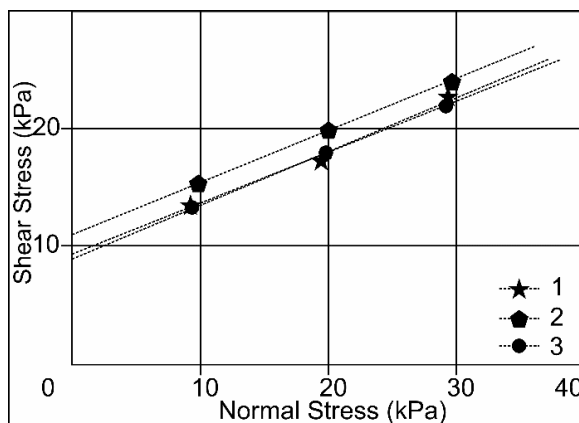
Fig. 4.4.3: Failure curves of samples

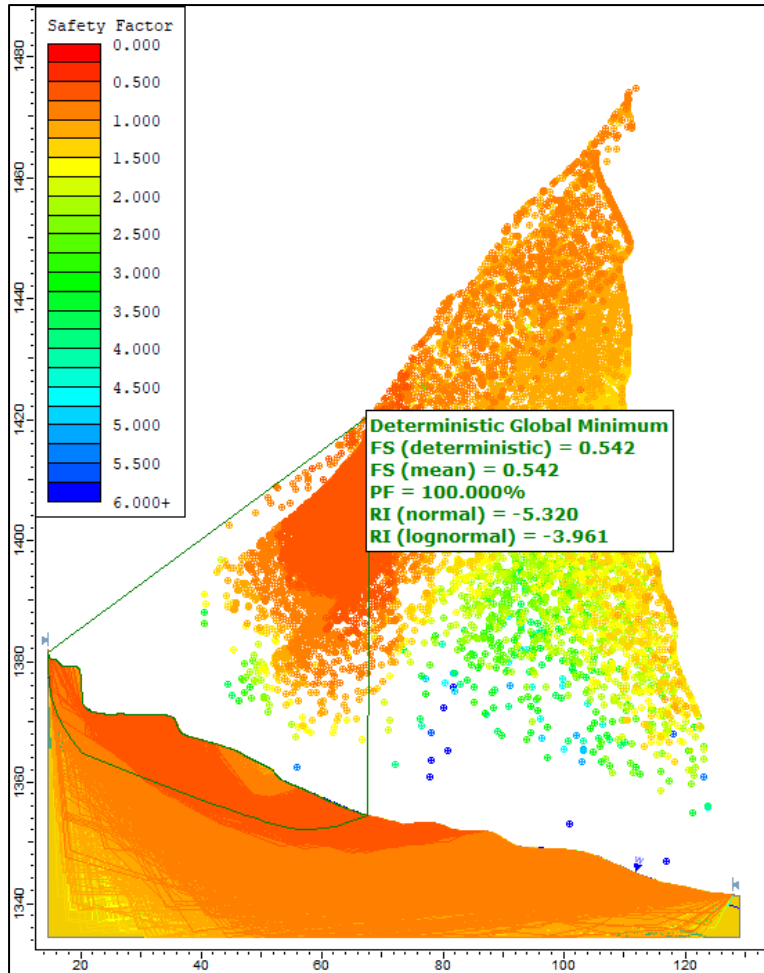
had a FoS <1. The minimum reliability index (RI) for slope safety is three (Kamien, 1997). However, in this area, an RI of -5.320 was obtained, which is insufficient for slope safety.

Fig. 4.4.4: Slope stability analysis with global minimum slip surface showing a safety factor of 0.542

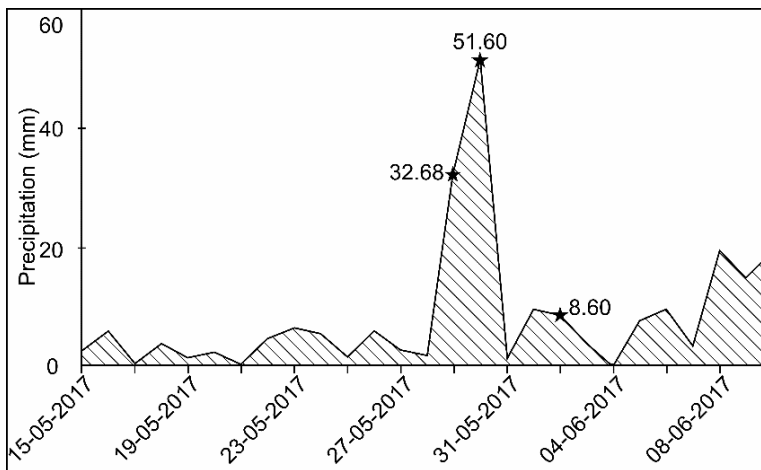
Fig. 4.4.5: Precipitation curve showing a spike in rainfall prior to the landslide event

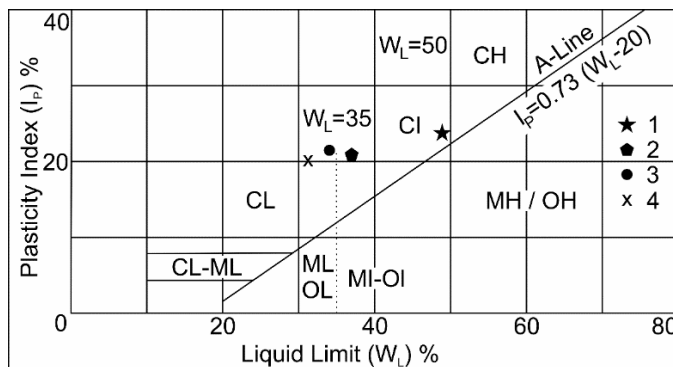
The plasticity chart shows soil samples 1 and 2 in the CI group (Fig. 4.5.2), indicating that they are inorganic clays of medium plasticity. Samples 3 and 4 belong to the CL category, which denotes inorganic clays with minimal plasticity. When compacted and soaked, such clays are impermeable and possess good shearing strength.

Fig. 4.5.2 Plasticity chart of the soil samples (M - Inorganic silt/very fine sand; C - Inorganic clay; O - Organic silt/clay; L - Low compressible and plastic silt/clay; I - Medium compressible and plastic silt/clay; H - High compressible and plastic silt/clay)

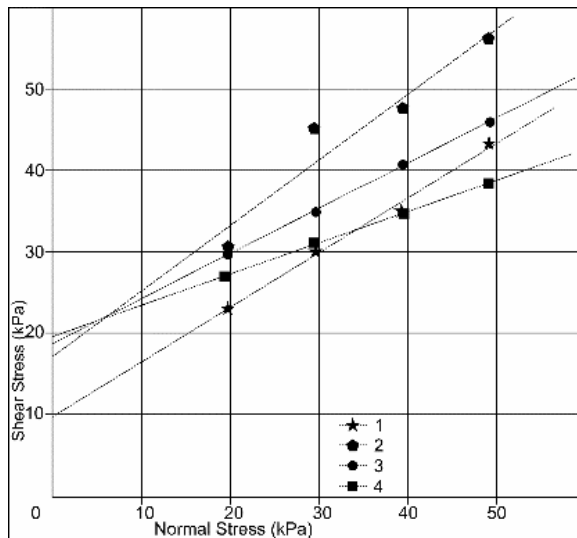
Fig. 4.5.3: Failure curves of the soil samples

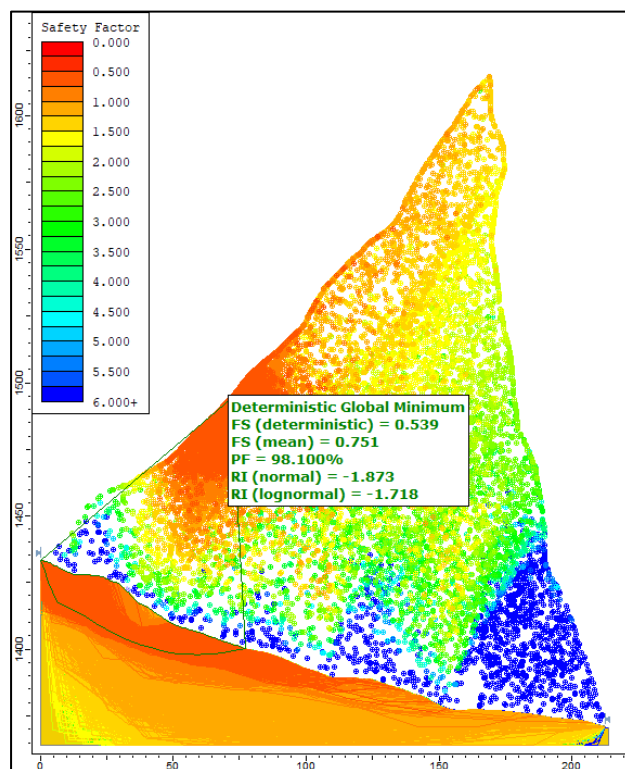
The probability analysis (Fig. 4.5.4) indicates that the deterministic safety factor is 0.539, with a failure probability of 98.10%. This indicates that 981 out of 1000 samples analysed would have a FoS <1. An RI of -1.873 was obtained, which is insufficient for slope safety.

Fig. 4.5.4: Slope stability analysis with global minimum slip surface showing a safety factor of 0.539

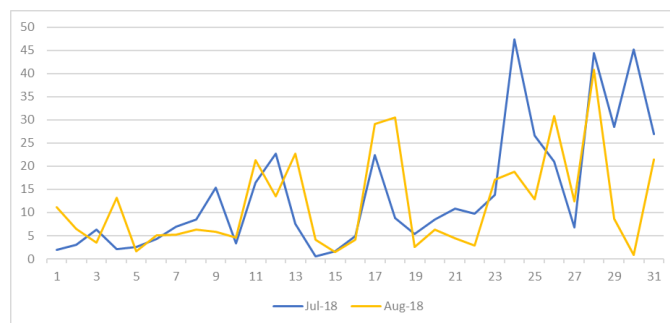
Fig. 4.5.5: Precipitation curve

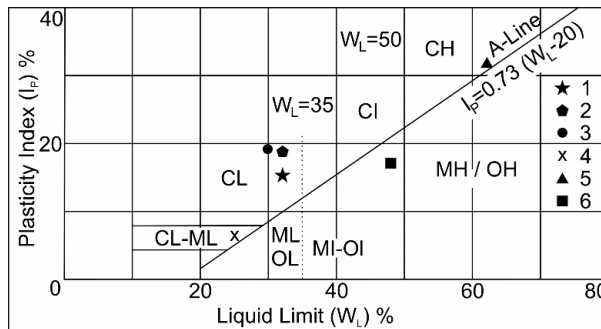
Fig. 4.6.2: Plasticity chart of the soil samples (M - Inorganic silt/very fine sand; C - Inorganic clay; O - Organic silt/clay; L - Low compressible and plastic silt/clay; I - Medium compressible and plastic silt/clay; H - High compressible and plastic silt/clay)

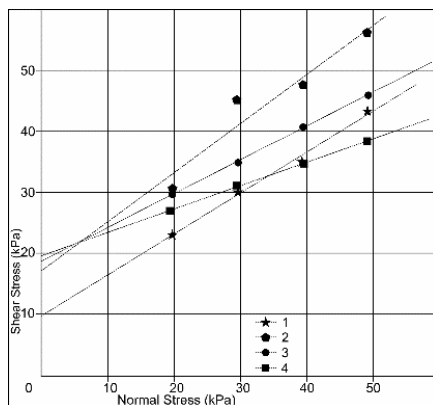
Fig. 4.6.3: Failure curves of samples

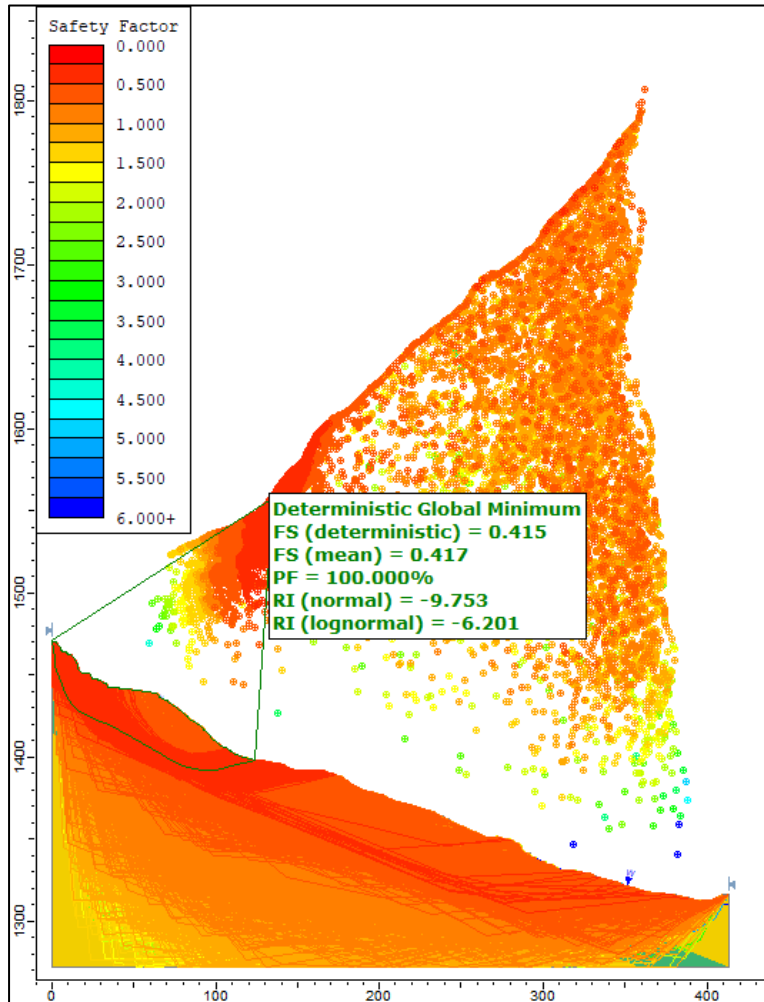
Probability analysis indicates that the deterministic safety factor is 0.415, with a failure probability of 100% (Fig. 4.6.4). This indicates that all analysed samples would have a FoS <1. In this area, an RI of -9.753 was obtained, which is insufficient for slope safety.

Fig. 4.6.4: Slope stability analysis with global minimum slip surface showing a safety factor of 0.415

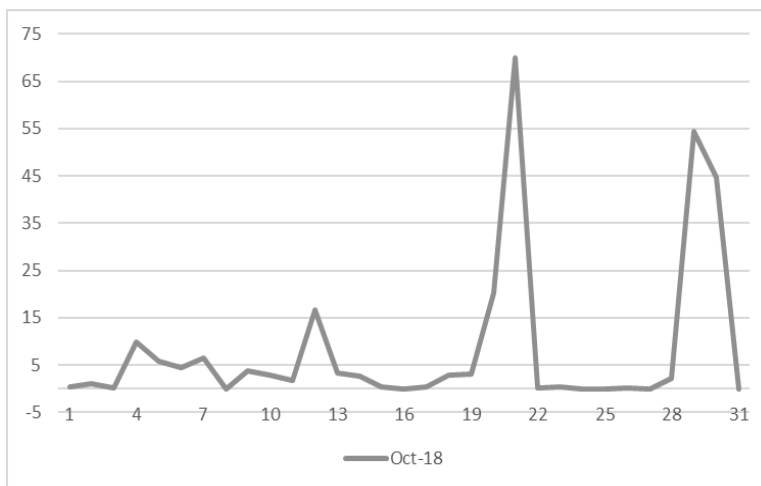
Fig. 4.6.5: Precipitation curve showing peak values at 32.68 and 51.60

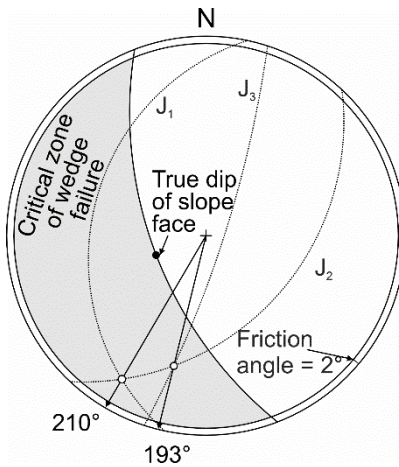
Fig. 5.1.1: Stereographic projection of slope and joints J_1 , J_2 and J_3

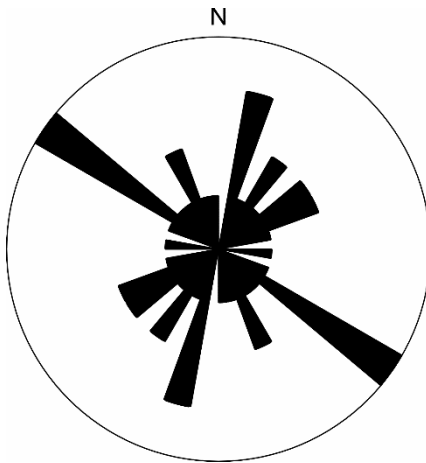
Fig. 5.1.2: Rose diagrams of rock joints of the study area

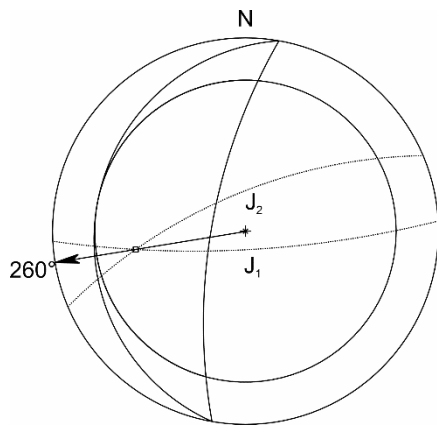
The stereographic projection of the dominant joint and the slope attitude (Fig. 5.2.1) indicates wedge failure, which is also evident in the field. The rose diagram (Fig. 5.2.2) shows that the dominant trends of the joints are aligned along NE-SW, NNE-SSW, and WNW-ESE directions. The NE-SW trend corresponds with regional trend. The WNW-ESE trend points to synthetic shearing of the rocks.

Fig. 5.2.1: Stereographic projection

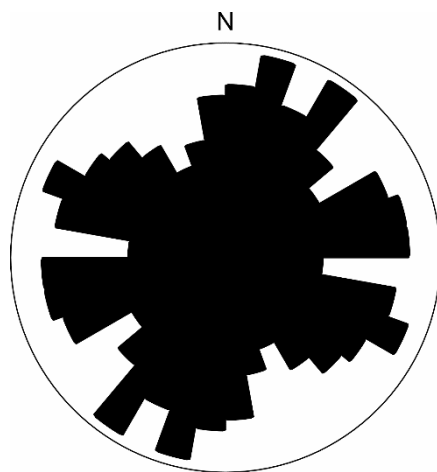
Fig. 5.2.2: Rosette

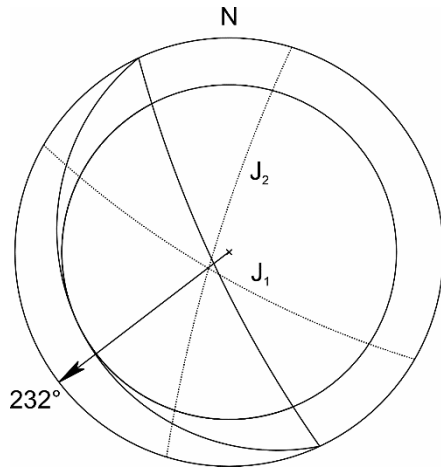
The cut slope and dominant joint sets (J_1 and J_2) are oriented 80° towards 245° , 77° towards 210° , and 82° towards 287° respectively. The joint sets J_1 and J_2 intersect to form a wedge towards S232°W (Fig. 5.3.1). This direction is related to the debris movement path at the landslide site. The joint set J_1 and the slope, with a strike difference of 35° , show some chance of planar failure. The rosette of the area shows a dominant NNE-SSW trend (Fig. 5.3.2). It also shows a WNW-ENE trend, which indicates synthetic shearing.

Fig. 5.3.1: Stereographic Projection

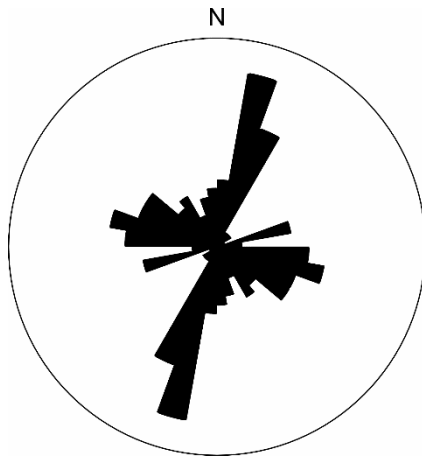
Fig. 5.3.2: Rosette

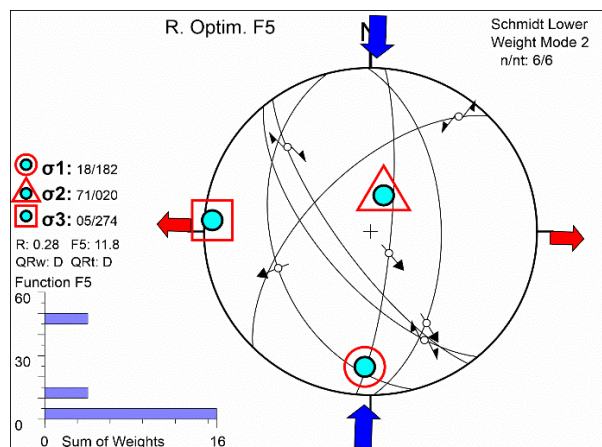
A stress ratio of 0.28 and R' of 1.76 are obtained. The analyses yielded the following values: $\sigma_1 = 18/182$, $\sigma_2 = 71/020$, and $\sigma_3 = 05/274$ (Fig. 5.3.3).

Fig. 5.3.3: Tensor generated by paleostress inversion as an effect of present-day thrusting in the region

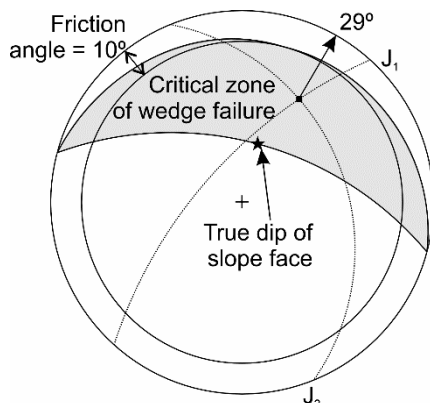
The joint data reveals two dominant joint sets (Fig. 5.4.1). Joint sets J_1 (66° due 312°) and J_2 (33° due 68°) form a wedge with a NNE (29°) trend. The combined data of the rocks in the rose diagram (Fig. 5.4.2) shows a NE-SW pattern, which is the regional trend in Nagaland.

Fig. 5.4.1: Kinematic analyses depicting probable wedge failure towards 29° (wedge formed by the intersection of J_1 and J_2)

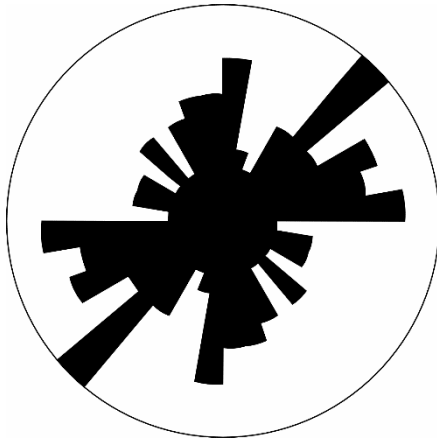
Fig. 5.4.2: Rose diagram of the joints of the study area

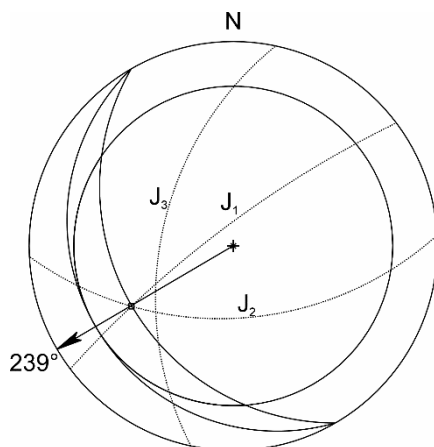
Fig. 5.5.1: Stereogram

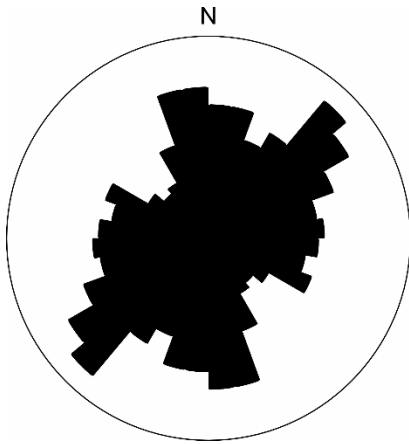
Fig. 5.5.2: Rose diagram

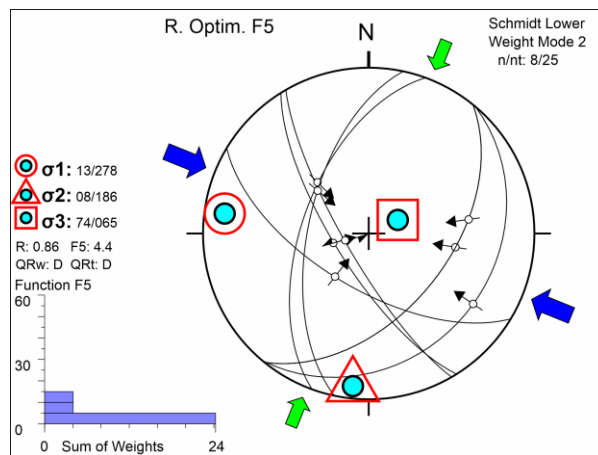
Fig. 5.5.3: Tensor generated by paleostress inversion as an effect of present-day thrusting in the region

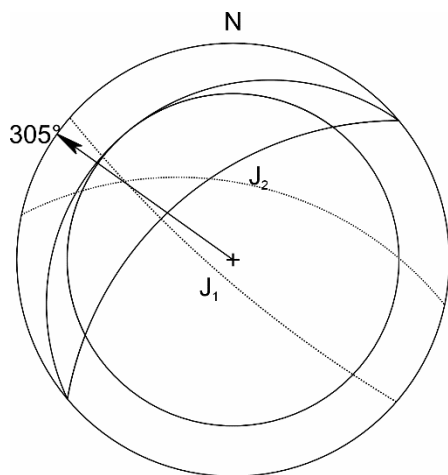
**Fig. 5.6.1:** Stereographic projection

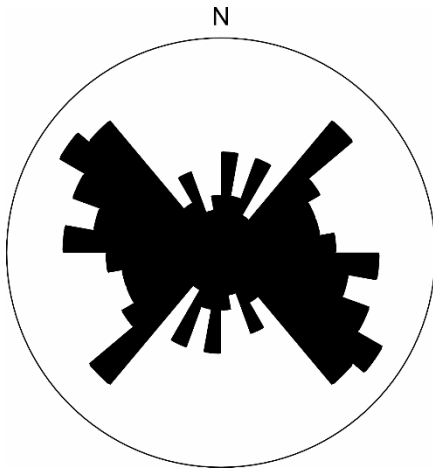
Fig. 5.6.2: Rosette

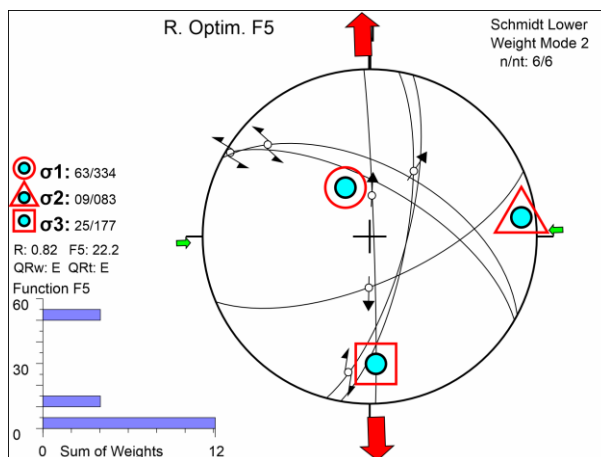
Fig. 5.6.3: Tensor generated by paleostress inversion as an effect of present-day thrusting in the region

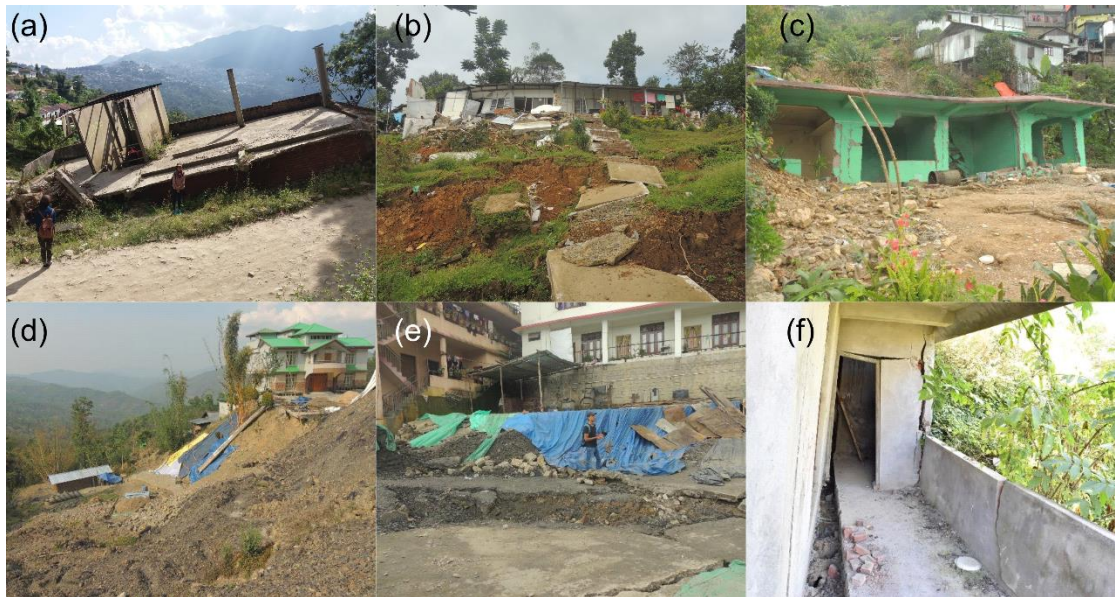
Fig. 6.1.1: Extent of damage at (a) Peraciezie, 2017, (b) Peraciezie, 2018, (c) Pezielietsie, (d) Nhachüko, (e) Perizie, and (f) Meriema

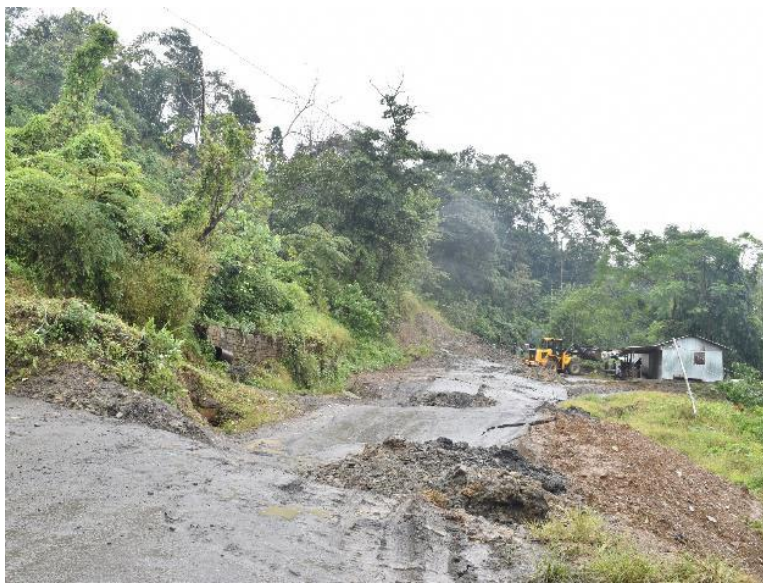
Fig. 6.1.2: Swelling of road sections along NH 2 at Meriema due to clayey soils

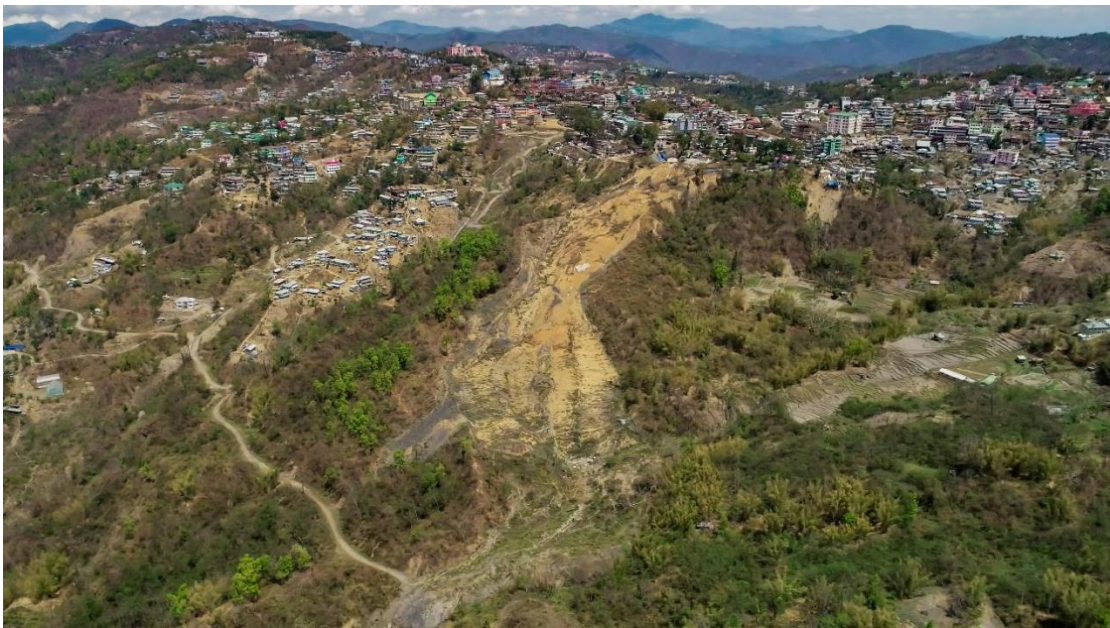
Fig. 6.1.3: Peraciezie slide, 2018

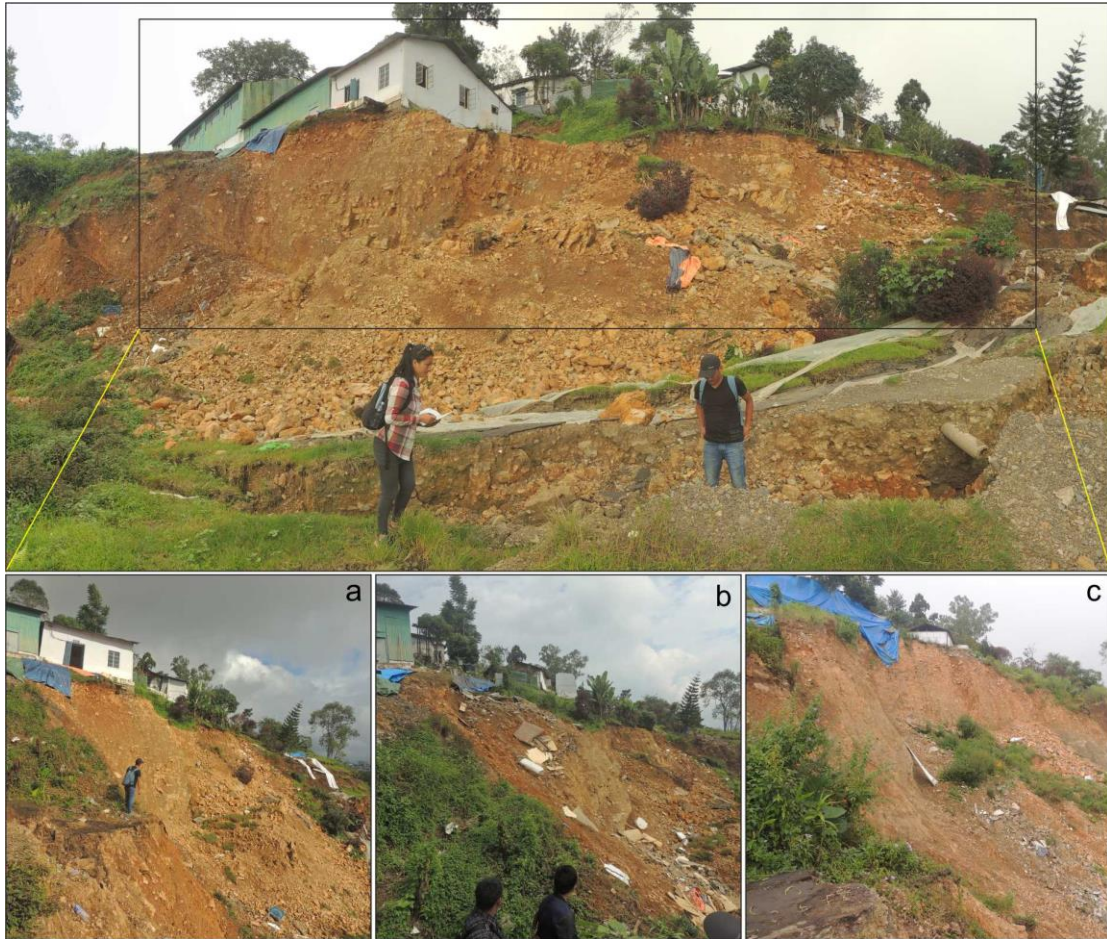
Fig. 6.1.4: Fractured shale at crown (Box - unstable scarp) in Peraciezie, 2018. Changes at crown: a) 30th August 2018; b) 13th September 2018; c) 31st August 2019

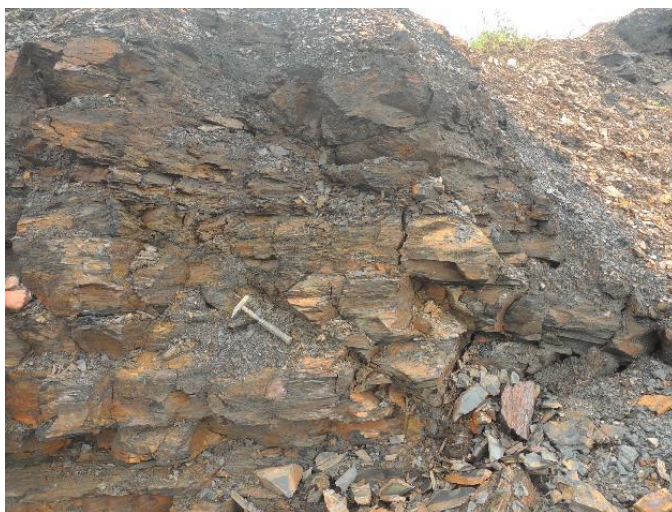
Fig. 6.1.5: Shale outcrop with large open fractures at Pezielietsie slide zone (2018)

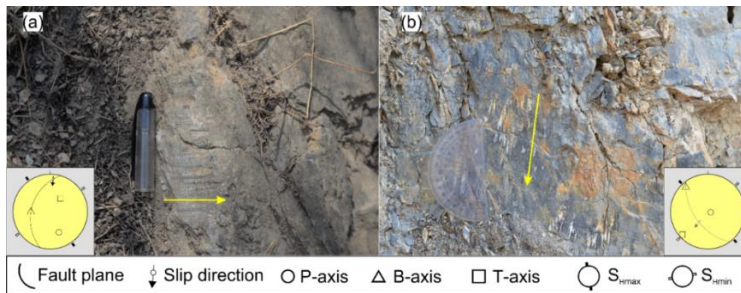
Fig. 6.1.6: Fault planes with slickensides (Inset-Schmidt stereonet displaying kinematic axes) and slide directions (yellow arrows) (a) Slickensided surface with reverse fault and sinistral movement; (b) Normal fault

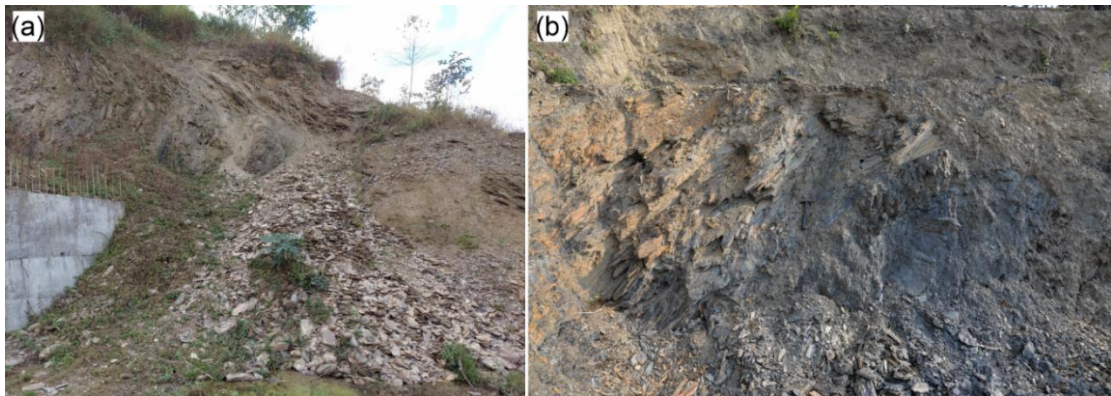
Fig. 6.1.7: (a) Folded and brittle rocks; (b) Sheared rocks
