**SLOPE STABILITY STUDIES OF SOME WEAK ZONES
BETWEEN HOSPITAL COLONY AND JOTSOMA
BYPASS, KOHIMA, NAGALAND**

THESIS
SUBMITTED TO
NAGALAND UNIVERSITY

IN PARTIAL FULFILMENT OF THE REQUIREMENT FOR THE
DEGREE OF DOCTOR OF PHILOSOPHY IN GEOLOGY

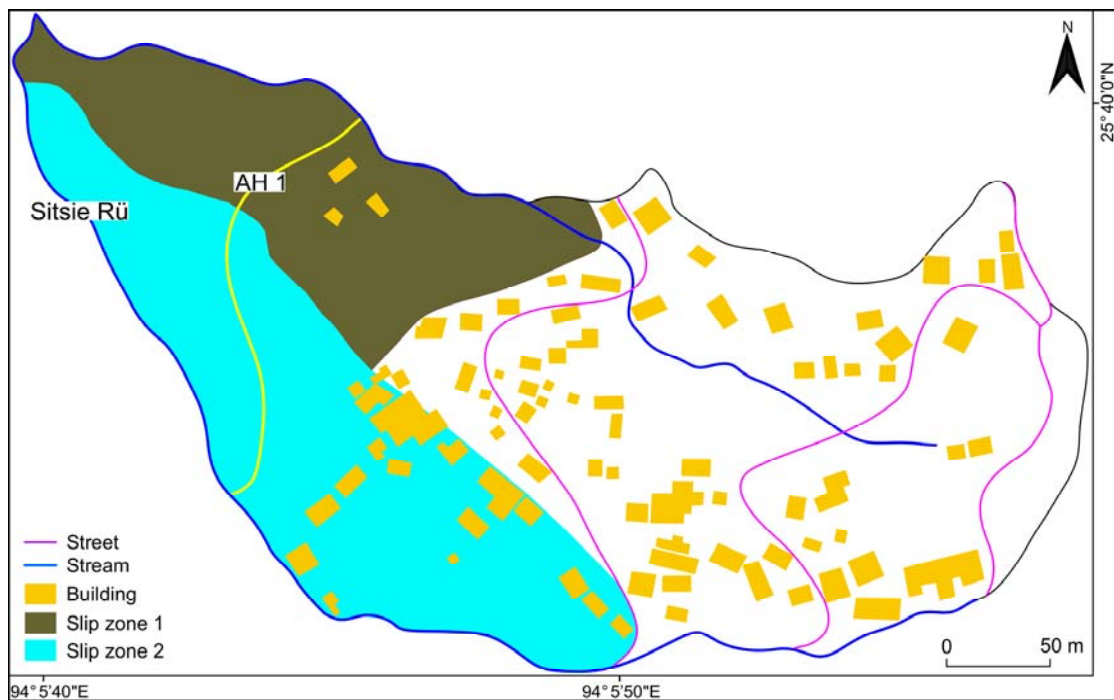
Fig 4.1.3b: Officer's Hill colony landslide map

The slope map (Fig. 4.1.3a) categorizes the study area into very gentle, gentle, moderate, steep, and very steep. The contours and field observations were used to develop a micro-slip map, demarcating two weak zones and movement viz., Slip zone 1 and Slip zone 2 (Fig. 4.1.3b) on the western portion of the study area. The AH 1 runs through these two weak zones.

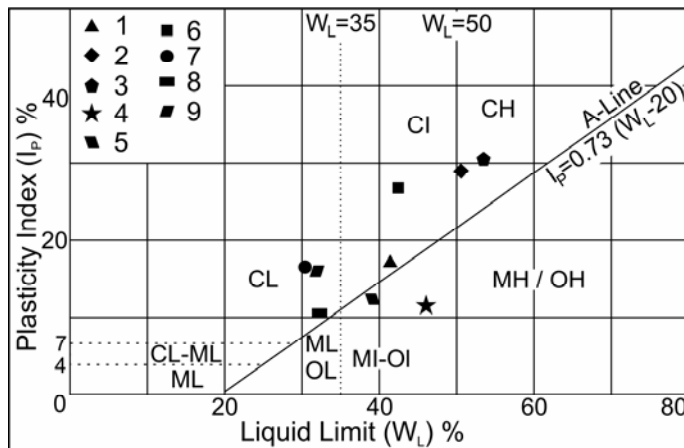
Fig. 4.1.4: Plasticity chart

From the plasticity chart (Fig. 4.1.4), it is observed that soil samples 7, 8 and 9 falls in the CL field indicating inorganic clays of low plasticity. Samples 1 and 6 falls in the CI field suggesting inorganic clays of moderate plasticity. Samples 2 and 3 falls in the CH field indicating inorganic clays of high plasticity. Samples 4 and 5 falls in the MI-OI field, which point to inorganic silts-organic clays of moderate plasticity.

It has been found that sample 2 and 3 possessing higher cohesion values, shows high W_L values (Table 4.1.1). This is indicative of high clay content in the soil and plasticity (sample 2 and 3), also classified in the Plasticity chart (Fig. 4.1.4). It has been observed that the water content determined at failure shows an increasing trend with respect to cohesion values (Table 4.1.2). This suggests that during the shearing process, soils with high cohesion absorb more water before deformation takes place due to more water retention capacity. Conversely, soils with lower cohesion such as sample 1 and 5 tend to fail at lower water content.

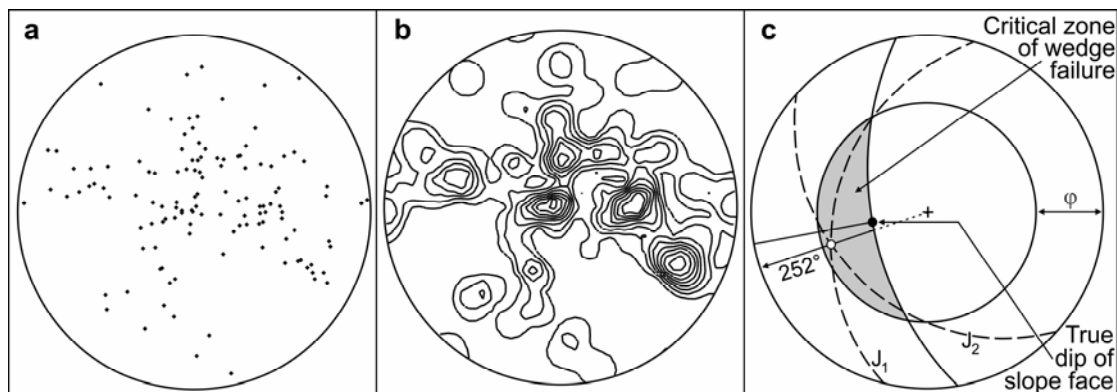
No. of joints measured	127
Slope orientation	$55^\circ/260^\circ$
Orientation of principle joint sets	$J_1 = 34^\circ/286^\circ$ $J_2 = 33^\circ/222^\circ$
Internal friction angle (ϕ)	26°
Type of failure	Wedge
Data format	Dip / dip direction
Magnetic declination	-0.367 (west declination of the study area)

Fig. 4.1.6: **a** - Pole diagram; **b** - Contour diagram; **c** - Stereographic projection

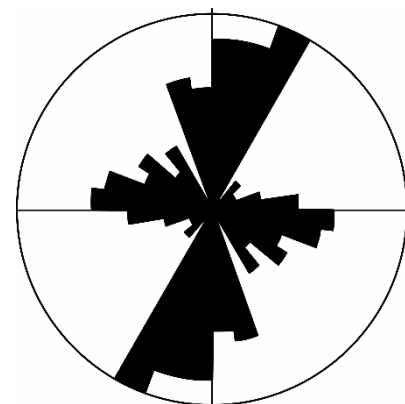
Fig. 4.1.7: Rose diagram

The rose diagram generated from the joints of the study area shows the development of a prominent NNE-SSW trend (Fig. 4.1.7), which is the approximate strike of the axes of the folds and thrusts of the region. The study area is crossed by lineaments trending in NE-SW, NW-SE, E-W and NNW-SSE directions (Fig. 4.1.8). Two minor NE-SW trending thrusts are seen in the central portion of the study area (Fig. 4.1.8). Sandstone beds

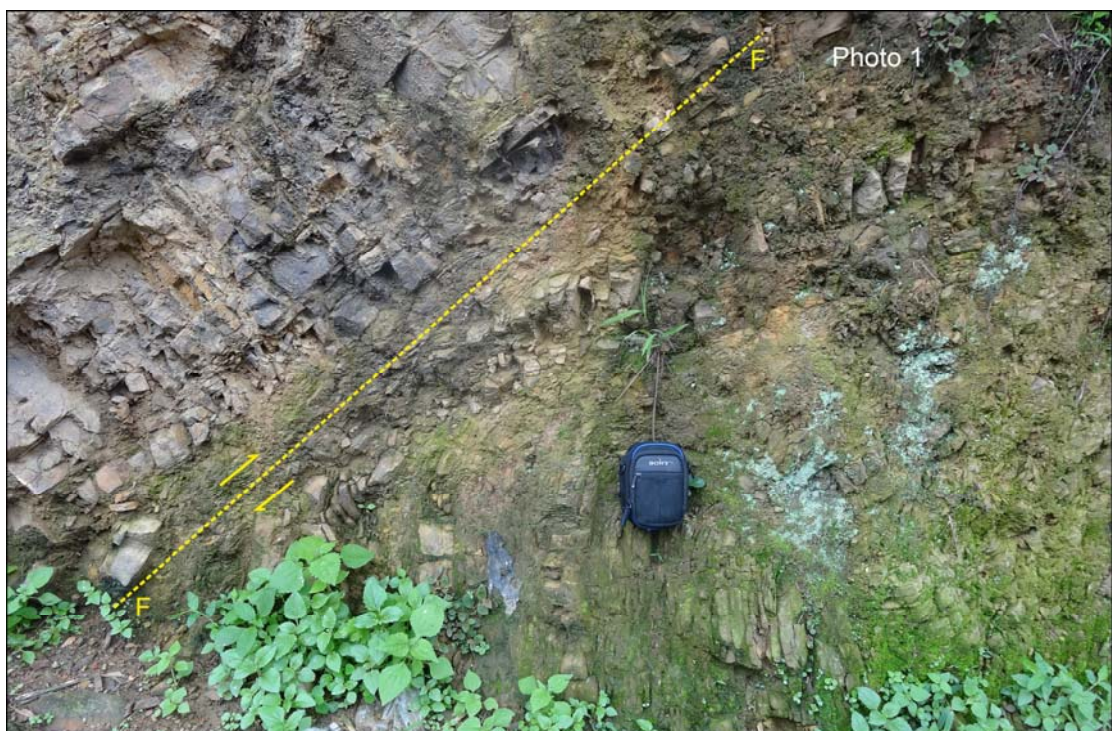
constituting the hanging wall block are seen overriding the footwall of shale (Fig.

4.1.9) in the vicinity, lending evidence of small-scale thrusting of the rocks. Rock exposure in the study area show a set of beds that has been affected by flexural folding, perhaps due to shearing stresses (Fig. 4.1.10). These folded beds bear a faulted relationship with the associated steeply inclined undisturbed beds.

Fig. 4.1.9: Bedded sandstones overriding silty shales

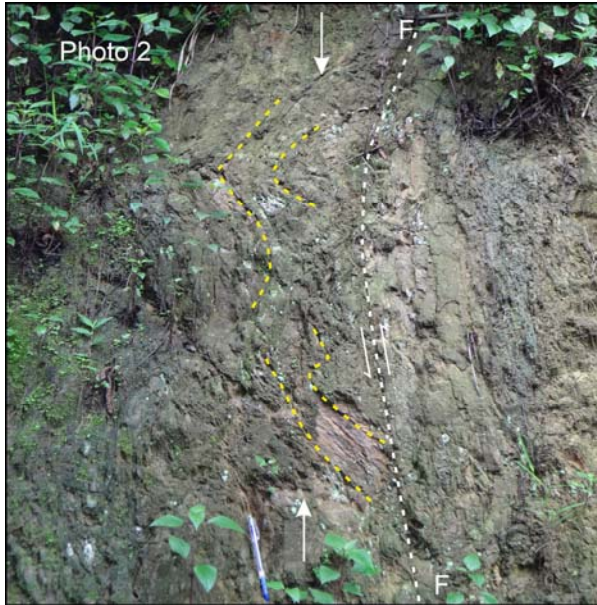
Fig. 4.1.10: Flexure folds on left of fault plane

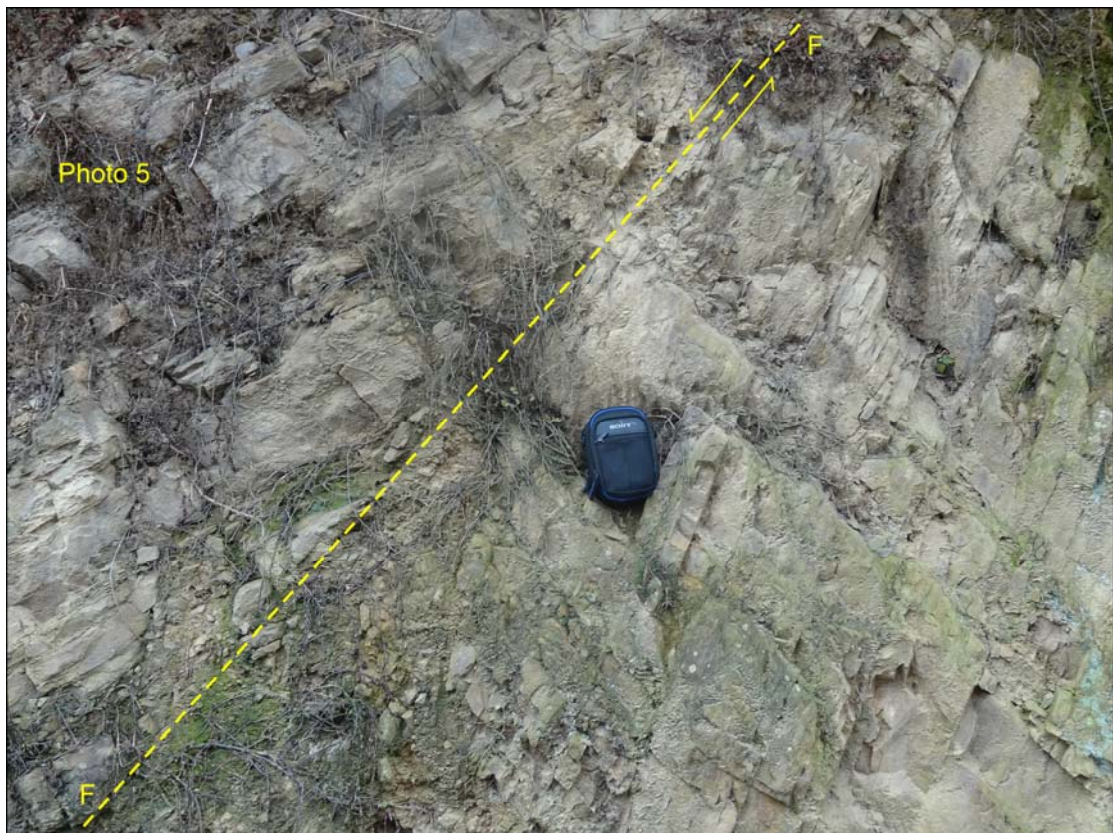
Fig. 4.1.12: Normal fault in the study area

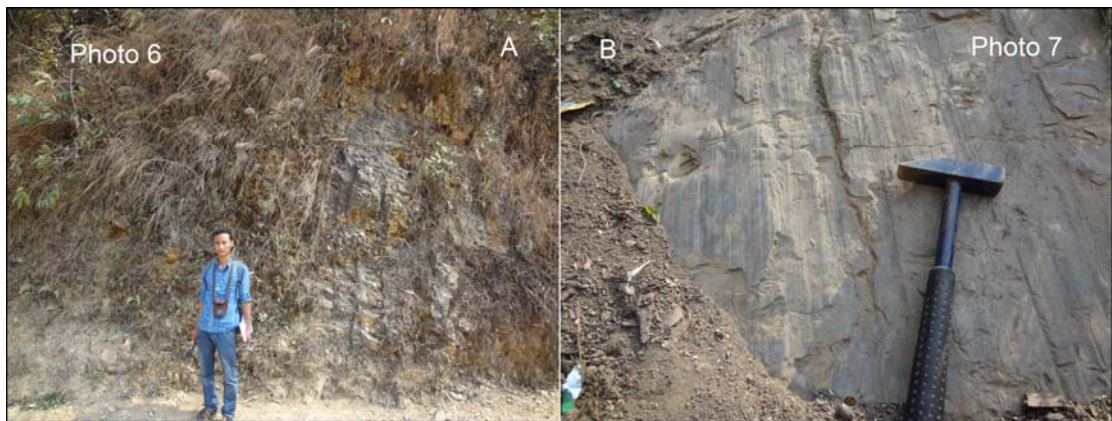
Fig. 4.1.13: A - Near-vertical beds in the study area; B - Slickenside in the bedrock

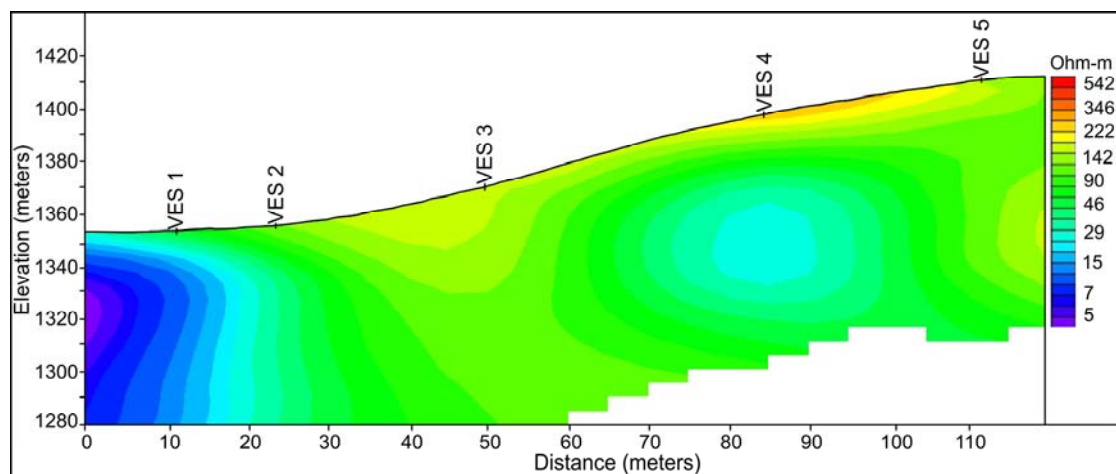
Fig. 4.1.20: 2D image showing a pseudo-section of the area with VES stations

A low resistivity zone of <15 ohm-m is seen at VES 1 at a depth of about 15 m (Fig. 4.1.20), which characterise an area of high water content. The zone of high conductivity is indicative of a fault, which is also identified as a thrust in the middle of the study area (Fig. 4.1.8). At the lower portions of the slope, deep cracks have developed on the surface (Fig. 4.1.21), representing the outer rim of the instability. Such fissured layer paves a pathway for water and infilling materials such as clays. When clays are saturated, ion-exchange takes place resulting in release of large number of ions. This process normally increases the ion concentration in pore water which therefore facilitated easy flow of electrical current, and the net result being an increasing conductivity (Ammar and Kamal, 2018).

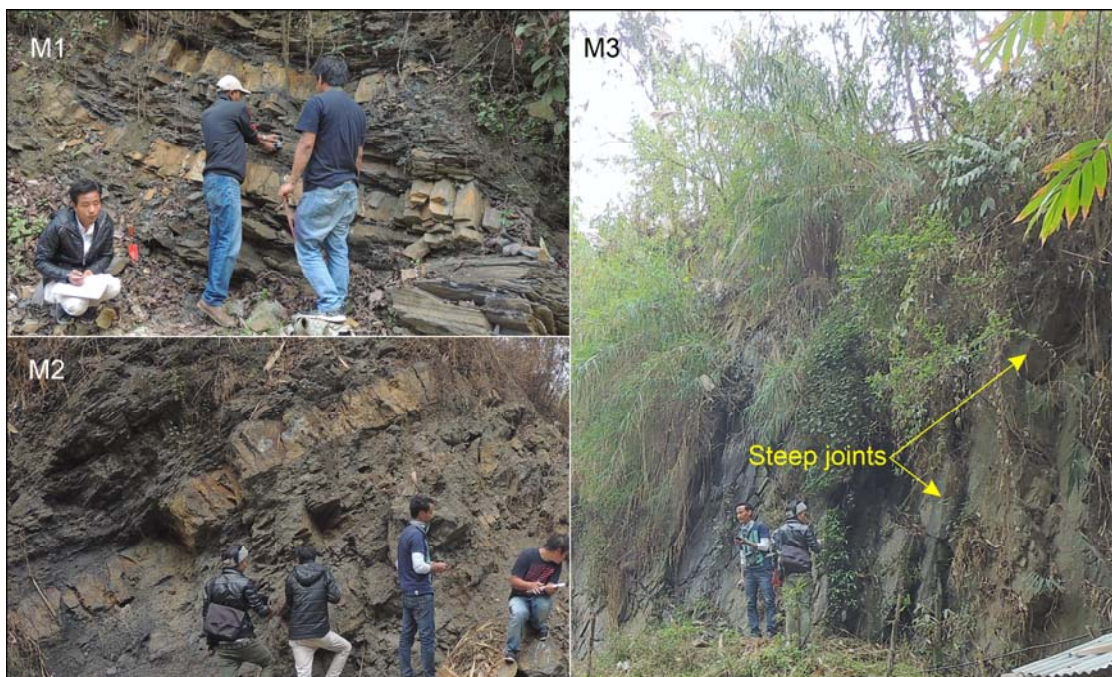
Fig. 4.2.5: Rock exposures of the studied slopes

The data were collected mostly along the streams of Dzulikha Rü and Sitsie Rü from slope M1, M2 and M3 (Figs 4.2.1, 4.2.5). Sixty six rock samples were collected from undisturbed rock exposures for point load test. From the analyses, an average strength of 1.51, 1.2 and 2.71 MPa were obtained from slope M1, M2 and M3 respectively (Table 4.2.3). The point load index (PLI) of the rock samples obtained from all the sampling sites show higher strength in sandstones with an average of 2.73, 2.04 and 4.58 MPa, while that of low strength shales gave an average values of 0.28, 0.36 and 0.83 MPa respectively.

The SMR values of 33 and 21.3 obtained from M1 and M2 respectively, falls in stability class IV which suggests unstable slope conditions (Table 4.2.4). Higher RMR and SMR values of 50 and 54 respectively are noted in M3. This slope falls in stability class III indicating partially stable slope.

Kinematic analyses were performed using 60, 227 and 80 joint attitudes from rock slopes M1, M2 and M3 respectively. From the joint analyses, pole diagrams (Fig. 4.2.6a) and contour diagrams (Fig. 4.2.6b) were constructed, from which dominant joints were identified. These were plotted against slope attitudes in stereographic projections (Fig. 4.2.6c). Two dominant joint sets are identified in M1 and M2, while only one set is registered in M3. In rock slope M1, the direction of the line of two intersecting discontinuity sets J_1 and J_2 are oriented 28° due 287° and 37° due 36° (Fig. 4.2.6c). This intersection produced a wedge trending NNW (337°). In slope M2, joint sets J_1 (42° due 55°) and J_2 (47° due 18°) intersect to produce wedge with NE (51°) trend. In slope M3, poles of discontinuities falling within the shaded portion have a chance of toppling failure whereas, those poles falling outside the shaded portion have less chance of toppling failure. The occurrence of toppling failure in this slope is certain due to the steeply inclined discontinuities (Fig. 4.2.5).

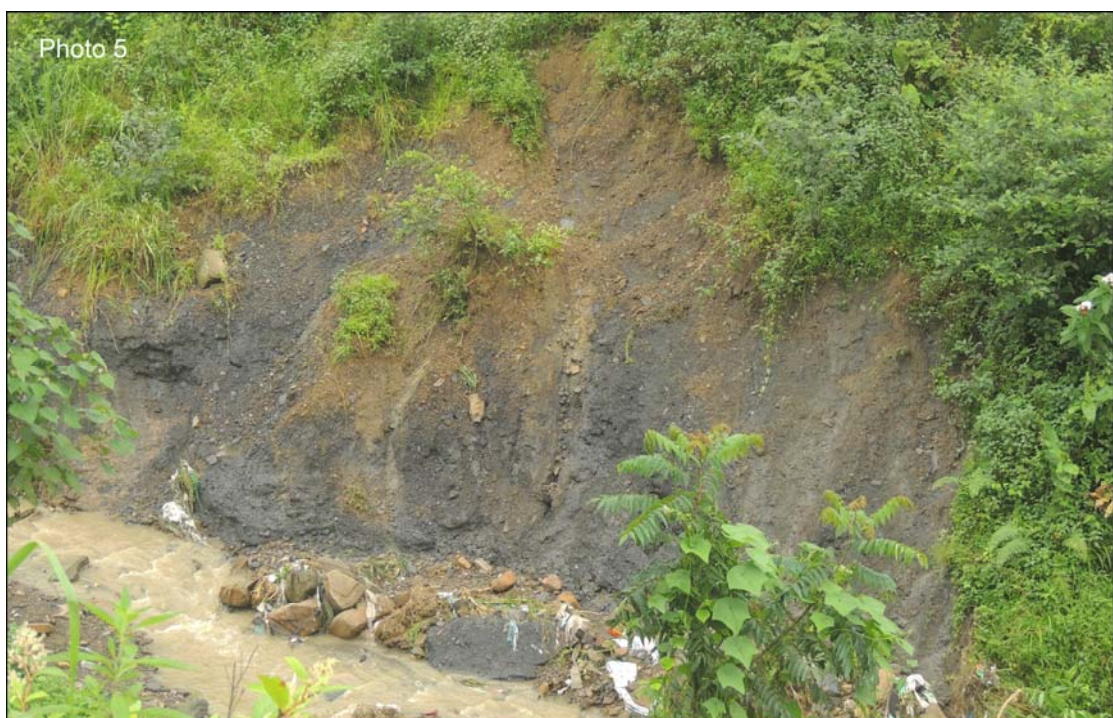
Fig. 4.2.12: Exposures of shale and clay along stream section

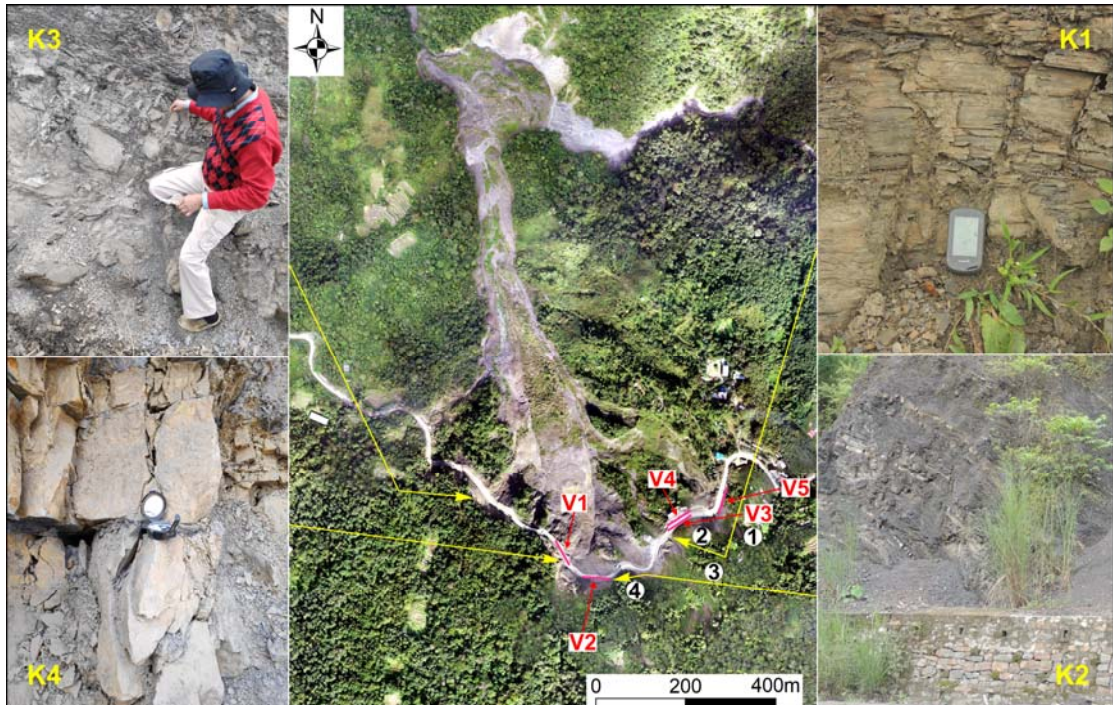
Fig. 4.3.4: **K1, K2, K3, K4** Rock exposures in the study area; **1, 2, 3, 4** Soil sampling sites for geotechnical analyses; **V1, V2, V3, V4, V5** Vertical electrical sounding sites (Pink lines) for resistivity survey profiles

The rocks exposed along the highway were evaluated for slope mass rating (Fig. 4.3.4). Eighty rock samples were collected from the 4 locations for point load test. Average point load index (PLI) values of 0.532, 0.383, 0.469 and 1.681 MPa were obtained for slope K1, K2, K3 and K4 respectively (Table 4.3.3). Since the index strength (average PLI) of K1, K2 and K3 are less than 1 MPa, as recommended by Bieniawski (1989), UCS was applied (Eq. 3.7). In order to maintain uniformity, index strength of K4 (1.681 MPa) was also converted to UCS (Table 4.3.4). Based on this rating scheme, it is found that the point load strength and UCS of K4 displayed the same rating even after conversion showing good correlation.

RMR values estimated for K1, K2 and K3 are 30, 32 and 30 respectively. The SMR values for slopes K1, K2 and K3 are 20, 36 and 34 respectively. Higher RMR and SMR values of 42 and 46 respectively are noted in slope K4. SMR values for slopes K1, K2 and K3 indicate unstable slope conditions. Clay-infilling is common within the rock masses due to easy infiltration of surface runoff into the numerous joints and fractures. Water seepages were observed at places during the dry season (10th April 2019; 3rd February 2020). The low UCS values of these rocks point to the effect of continuing weathering, which results from seasonal fluctuations of groundwater levels. The partially weathered shales, being highly sensitive to water, are prone to sudden drops in shearing strength in the presence of excess water, which reduces the stability of slopes. Erguler and Ulusay (2009) showed UCS reduction of up to 90% with increasing water content on clay-bearing rocks. Pellet et al. (2013) showed that both cohesion and internal friction angle of clay-infilled rocks decreased due to water saturation, causing reduction of strength by 50%. Higher RMR and SMR values of slope K4 indicate fairly stable rocks and partially stable slopes, which may be due to high frictional limit of the massive sandstones.

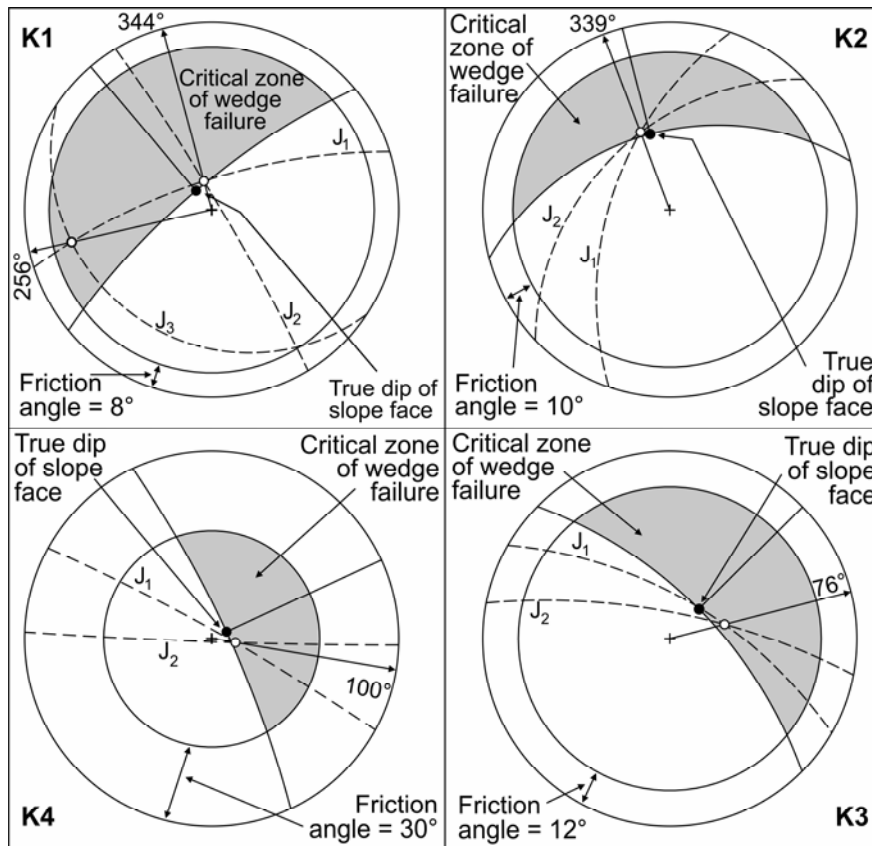
Fig. 4.3.7c: Stereographic projections

From input parameters (Table 4.3.6) the stereographic projections show wedge failure of the slopes (Fig. 4.3.7c). In slope K2, J_1 and J_2 form the perfect condition for wedge failure. In slope K3, the failure direction of the intersecting joint sets also indicates wedge failure along the ENE (076°) direction. The intersecting joint sets J_1 and J_2 in location K4 also provides conditions for wedge failure with an ESE (100°) trend.

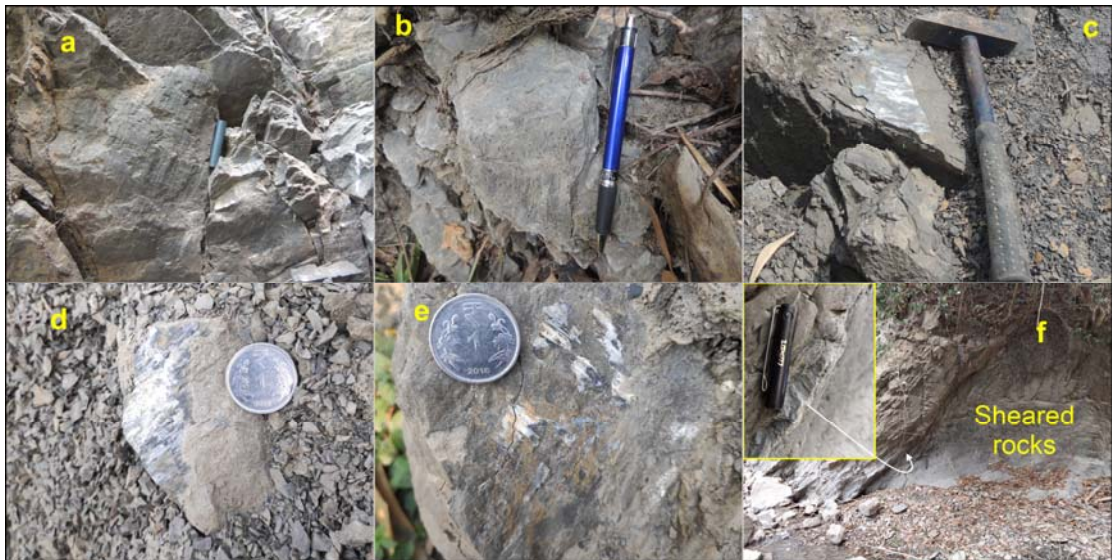
The rose diagrams of the rock slopes (Fig. 4.3.8) show the orientations of the joints of the study area, which are aligned NW-SE, ENE-WSW, NE-SW, NNE-SSW, E-W and WNW-ESE. The study area also shows faults trending approximately NE-SW, WNW-ESE, WSW-ENE, E-W and NNE-SSW (Fig. 4.3.9). The rocks also show the presence of slickensides (Figs. 4.3.10[i], 4.3.10[ii]-h).

Fig. 4.3.10[i]: Slickensides along fault planes

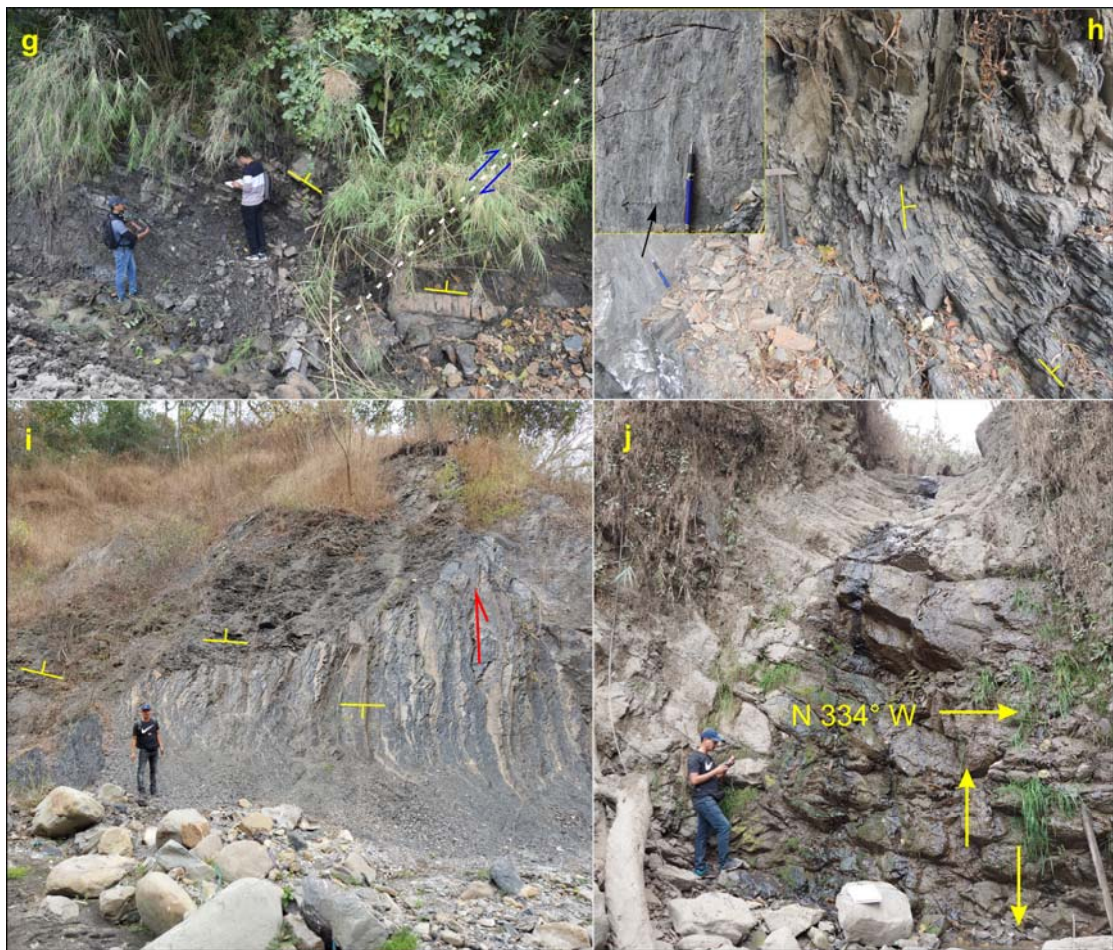
The NE-SW lineaments (Fig. 4.3.8-R2) in the study area conform to the regional trend of the thrusts and major fold axes of Nagaland. A thrust marked in the area trends approximately NE-SW along g-h (Fig. 4.3.9). An outcrop in the study area depicts the thrust relationship of the rocks (Fig. 4.3.10[ii]-g). Another thrust mapped (Fig. 4.3.9) trends almost parallel to the former. At the outcrop, lower beds are seen thrusting upward (Fig. 4.3.10[ii]-i) and deforming the upper beds in the process. A normal fault trending WNW-ESE crosses this area (Fig. 4.3.9). A waterfall in the area (Fig. 4.3.10[ii]-j) lies along this fault. Synthetic shearing is dominant in these rocks. Two faults trending WSW-ENE mapped by visual examination of satellite imagery (Fig. 4.3.9), are dextral strike-slip faults. The E-W and NNE-SSW lineaments may be hybrid faults generated due to multiple stresses acting in various directions. The intense deformation of the rocks (Fig. 4.3.11) and presence of slickenside point to multiple stresses in the area, and possible ongoing tectonism.

Fig. 4.3.10[ii]: **g** Blocks displaced due to thrusting; **h** Slickenside along fault plane; **i** Steeply inclined beds thrust (red arrow) over younger rocks; **j** Waterfall along exposed scarp of normal fault

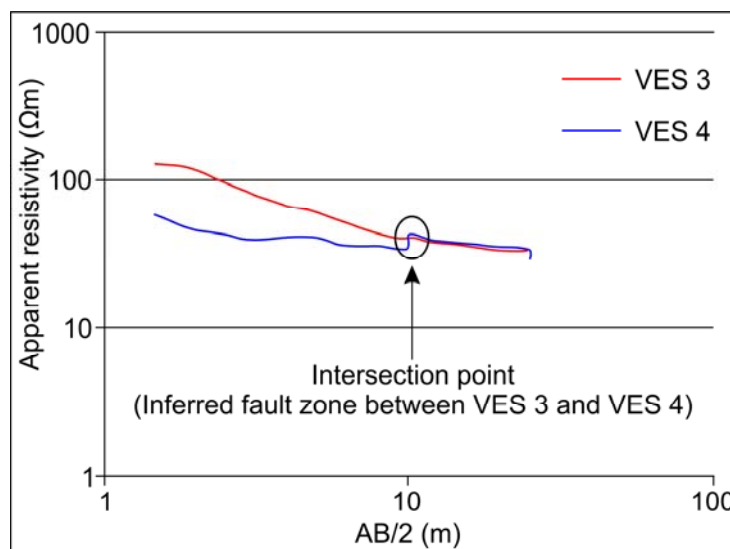
Fig. 4.3.13: Apparent resistivity curves showing an inferred fault

The resistivity method employed for the present study to detect the presence of faults, revealed areas of high water content. Considering the two assumptions after Ammar and Kamal (2018), the presence of a fault is inferred at the intersection between sections VES 3 and VES 4 (Fig. 4.3.13). The arrow in the figure shows the intersection point, which indicates the presence of a fault zone at shallow depth. This is also reflected in the lineament map (Fig. 4.3.9) of the study area which indicates strike-slip fault trending WSW-ENE.

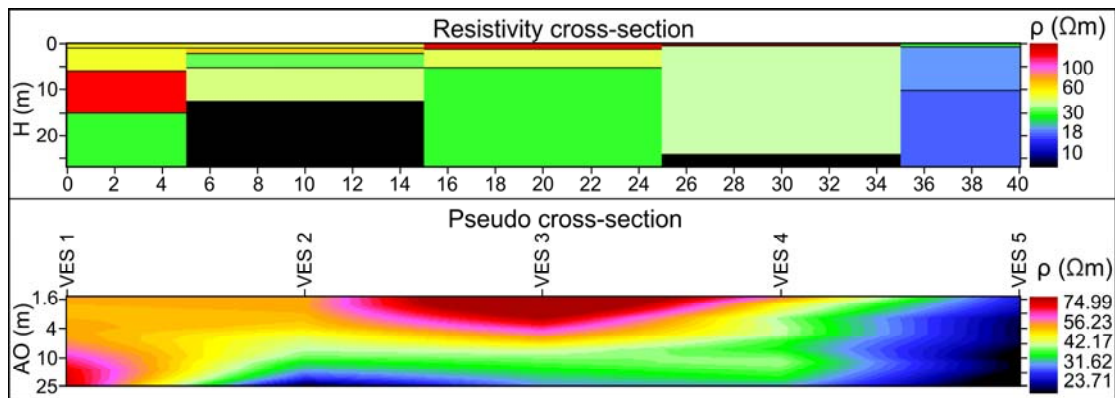
Fig. 4.3.14: Interpreted resistivity and pseudo cross-sections

Results of the pseudo cross-sections of the geoelectric field data for the VES stations (Fig. 4.3.14) indicate the presence of weak zones between VES 2 and VES 4, located at shallow depths of 8 and 10 m from the surface. This can be seen by zones of high resistivity values separated by zones of lower resistivity from the surrounding areas. A low resistivity zone, observed in VES 5, up to a depth of 25 m below ground level, continues towards VES 4 and VES 2. This zone is a highly potential source for groundwater. Layers of high resistivity ($>70 \Omega\text{m}$) at VES 1 and VES 3 range in depths from 15 to 25 m and 1.5 to 2.5 m respectively. These are indicative of fractured and/or weathered horizons in the subsurface. Such weak zones, which are also observed along the tributaries of the Dzütre Rü flowing through the study area, point to the presence of faults (Lashari et al., 2019).

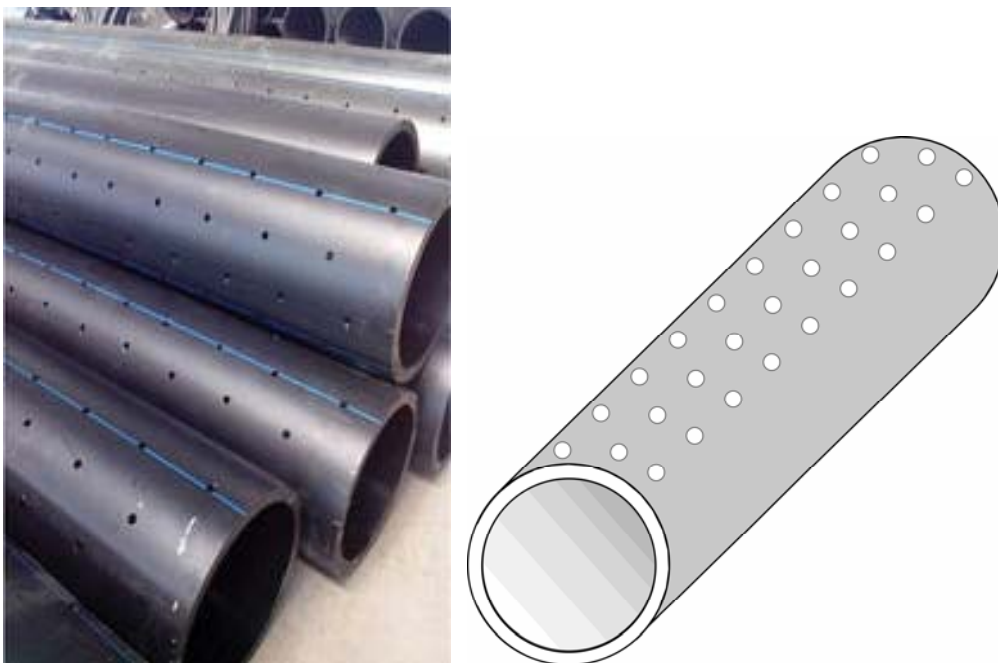
Fig. 5.1.3: Perforated pipes for subsurface use (Representational)

The presence of huge volume of subsurface water is a major problem in this area. This has led to differential settlements and subsidence of the road section, creating pore water pressure on the slope materials as well as erosion of finer materials. Perforated subsurface pipes (Fig. 5.1.3) are ideal under such circumstances to safely channelize this excess water away from the weak zones. These pipes can be made from any variety of materials including PVC (polyvinyl chloride), iron, cement and clay. They should have perforations and openings at the top through which the water can enter. The lower part must be properly lined so that the upslope water enters the pipe and are channelized away into the nearby streams.

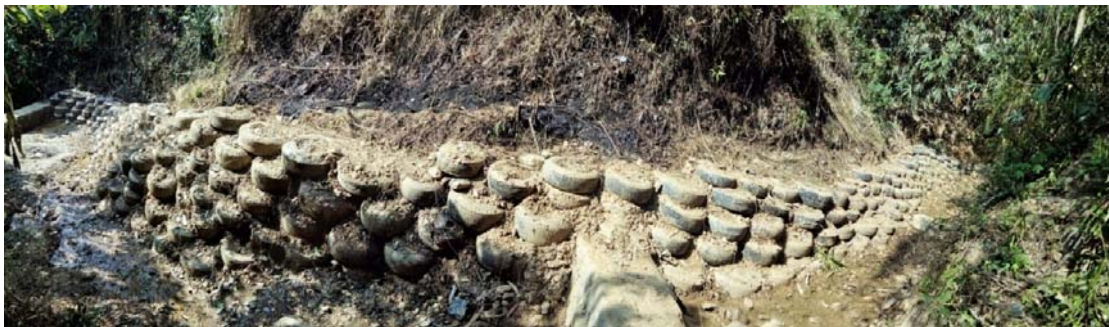
Fig. 5.1.4: Used tyres forming a protective wall against toe erosion (Representational; Source: Mr. Sukho Movi)

The stream channels in this weak zone, with the exception of Sitsie Rü, are narrow, highly erosive first order streams that are not lined by concrete. In such areas, treatment using old vehicle tyres is suggested over other structures that are made of rock and mortar. This approach lends credence to the fact that such rubber tyres are more resistant to erosion, lighter in weight and more elastic to any minor movement of the slope materials. Used tyres can be obtained in large quantities for throwaway prices (if not free) and therefore, their use would ensure a very inexpensive solution. A major impact on the environment is also averted using old tyres, which would otherwise be indiscriminately discarded to add to the pollution. The proper construction of a support wall involves filling the tyres with earth from the immediate surroundings. This earth is compacted into the tyre using a sledgehammer. This innovative method, started in Nagaland by Mr. Sukho Movi, Office Assistant in the Nagaland University, Kohima Campus. This method can be employed in the study area as embankment and retaining walls to control toe erosion by streams and ensure minimal loading on the fragile slope condition (Fig. 5.1.4).

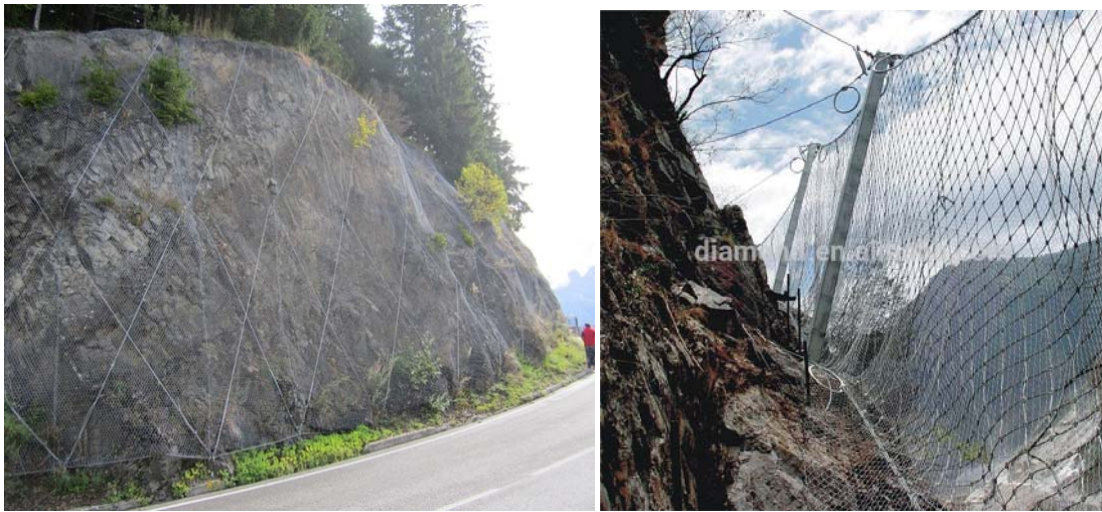
Fig. 5.1.5: Wire-mesh slope protection / Cable-net slope protection (Representational)

This area is characterised by slope possessing lithology with numerous weak planes such as joints or vertical fractures and is thus associated with rockfall and rockslides endangering the life of commuters and properties alike. Here, rockfall protection systems must be installed after proper calculation and designed in such a way that it is capable of absorbing the impact of the falling rock and must also contain such moving rocks from venturing into the road. Draped wire-mesh and cable net slope protections using double twisted gabion wire mesh or high tensile wire mesh

(Fig. 5.1.5) are recommended along the highway section in the study area where the fractured rocks are exposed. These systems are typically galvanized or PVC coated.

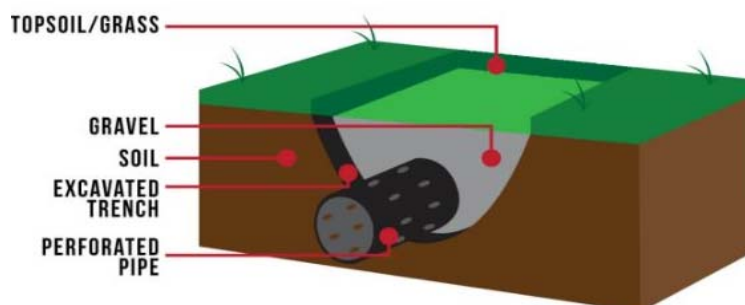
Fig 5.3.1: Typical French drain (Source: <https://northwestdrainage.com/wp-content/uploads/2020/09/northwest-french-drain-seattle-redmond-everett-drains.jpg>)

The slope materials display high degree of saturation, specially above the highway. In such scenario, the main aim would be to minimise the percolation of water from rainfall and surface run-off into the slope. Increased percolation of water

from rainfall and surface run-off would raise the water table and allow building up of hydrostatic pressure on the slope. Natural plants such as broom grass carpet, narrow leaf carpet grass and broadleaf carpet grass are recommended in such areas to restrict infiltration of such surface water. Opting for such light treatment methods would ensure very little amount of water percolating below as it will create a carpeting effect and surface water will easily flow over it, root system will bind and hold together the loose soil giving a more stable structure, and very importantly impose very negligible weight on the fragile slope material as compared to other heavy RCC structures. This slope protection and erosion control measures can be fortified by building adequate surface drainage. In areas where the slopes are stable, proper concrete lined nullahs can be laid out. However, in soft and unstable soils like clay, embankments and retaining walls built by using old vehicle tyres (Fig. 5.1.4) are suggested since such tyres will occupy comparatively more space and lighter in contrast to reinforced structures which will lead to undue loading in the fragile environment. The horizontal stress exerted by the upslope material as well as vertical load by passing vehicles can also be dissipated to some extent due to the elastic nature of the tyre material. Installation of French drain type will reduce water percolation into deeper horizons, prevent retention of water and drain out excess water during heavy rainfall. A French drain also known as Filter drain consist of a trench filled with gravel or rock containing a perforated pipe that redirects surface water and groundwater away from an area (Fig 5.3.1). The gravel and rock layer will allow easy flow of water. The water then, flows into perforated pipes at the bottom of the trench. From there it will eventually discharge to an outlet to a safer zone.
